Reverse Segmentable GainMaker Node OIB Shorting Condition Technical Bulletin

Part Number 78-4021645-01 Rev C

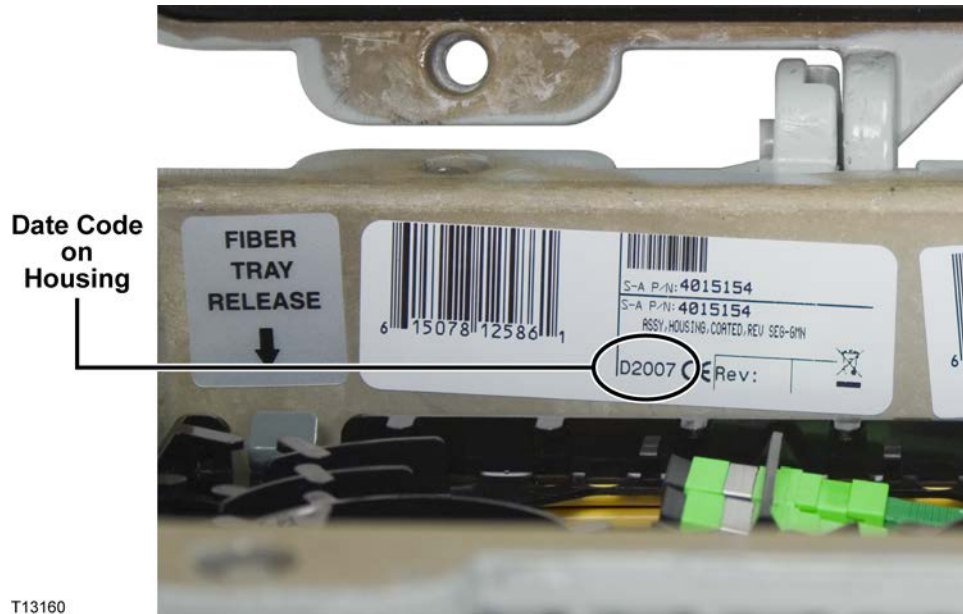
T13160

A sample date code label as it appears on the interior of a Reverse Segmentable GainMaker Node housing is shown below.

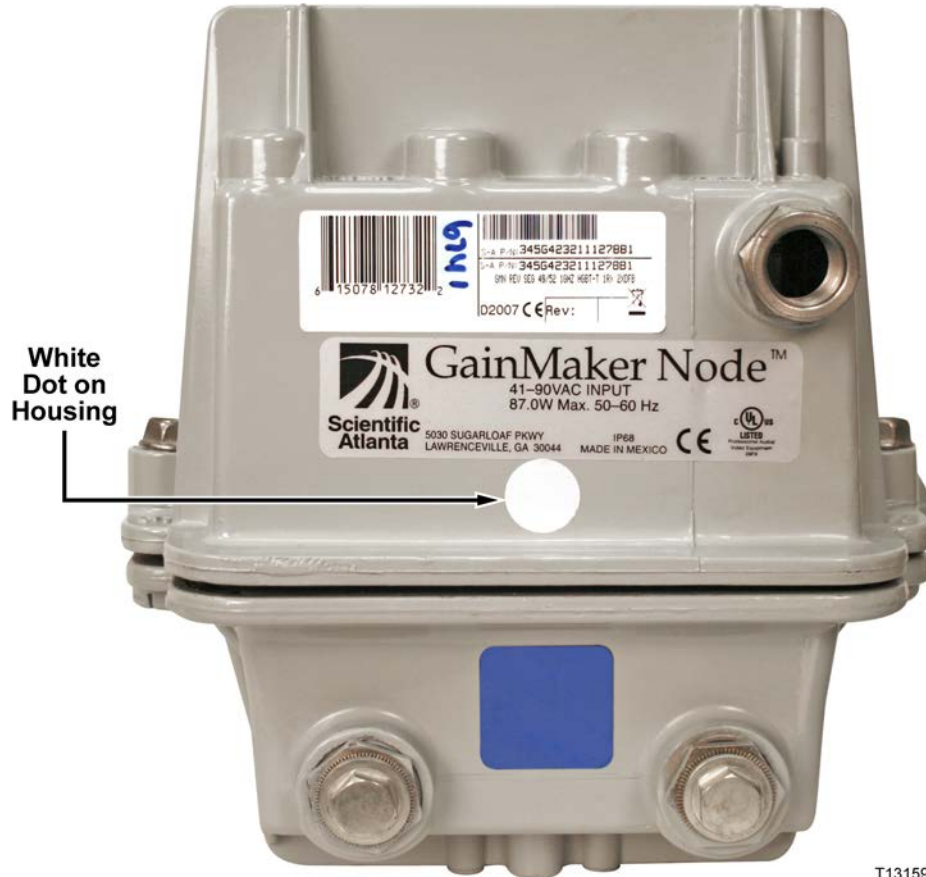
T13159

Units on which the OIB has been reworked (insulation added between the OIB and the housing boss) are identified by a white dot affixed to the fiber entry end of the node housing, as shown below.

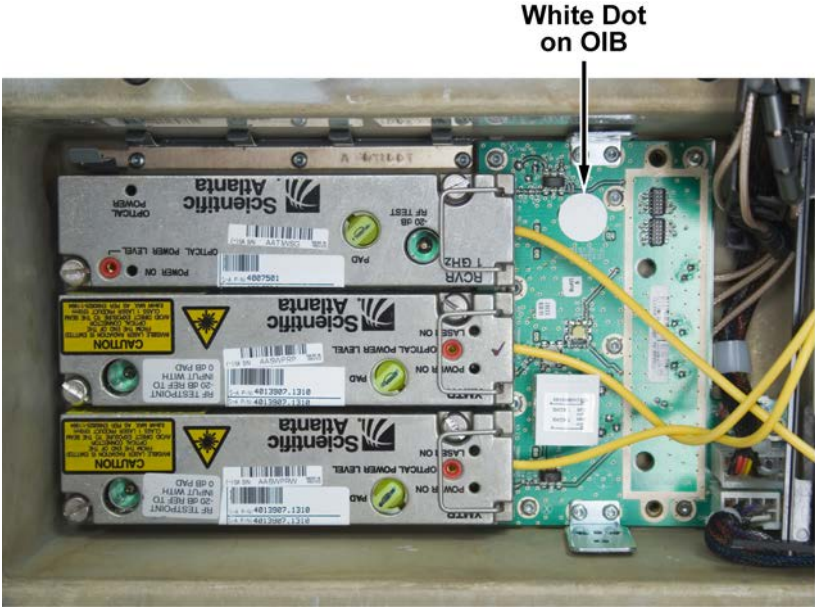
T13161

An identical white dot also appears inside a reworked node, affixed to the OIB just above the part number, as shown below.
