Troubleshoot PBB-EVPN ESI, ES Import RT and Source MAC Mismatch on ASR 9000

This document describes how to troubleshoot Ethernet Segment Identifier, Import RT, and Source MAC mismatch in PBB-EVPN multi-homed networks.

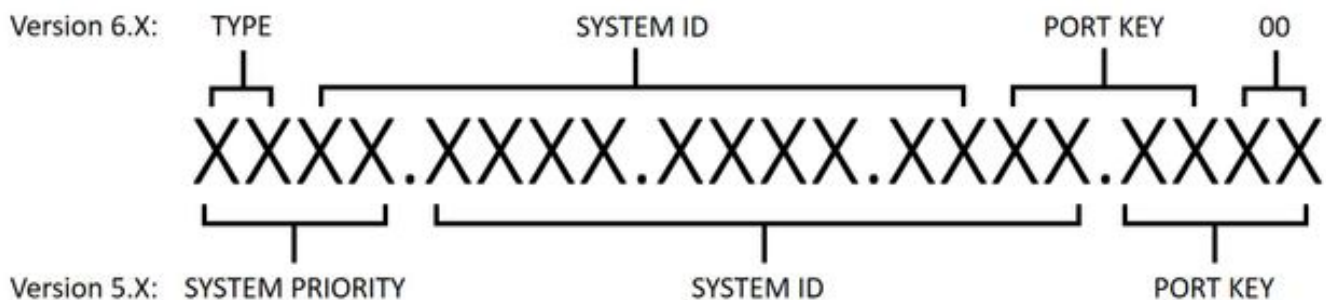
From ASR 9000 version 6.0, PBB-EVPN ESI format is changed to be RFC 7432 complaint. This means ESI auto-sensing cannot work between a PE 6.X and a PE on previous versions.

This diagram shows how the default ESI is generated for version 6.X and older versions.

Run **show evpn ethernet-segment detail** to check if the default ESI matches on all PEs. If not, manually configure ESI.

With ESI configuration, different software versions have different requirements. To meet these requirements, it is recommended to change ESI on all devices.
