# Release Notes for Cisco Aironet Access Points and Bridges for Cisco IOS Release 12.4(10b)JDA and 12.4(10b)JDA2

**November 30, 2008**

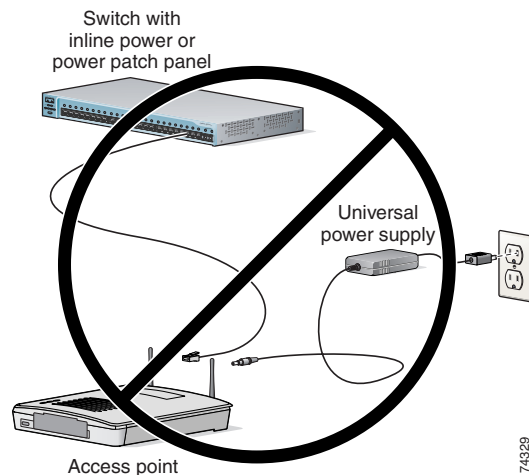
**Figure 2** *Improper Power Configuration Using Two Power Sources*

You cannot provide redundant power to 1130 series access points with both DC power to its power port and inline power from a patch panel or powered switch to the access point Ethernet port. If you apply power to the access point from both sources, the switch or power patch panel might shut down the port to which the access point is connected. [Figure 2](#) shows the power configuration that can shut down the port on the patch panel or powered switch.
