Verify Configuration of TTS Prompts Not Being Played Correctly when in Chinese Language

This document describes the solution for Text to Speech (TTS) Prompts not playing when the Prompts created using the Create TTS Prompt step are being set to Chinese Language.

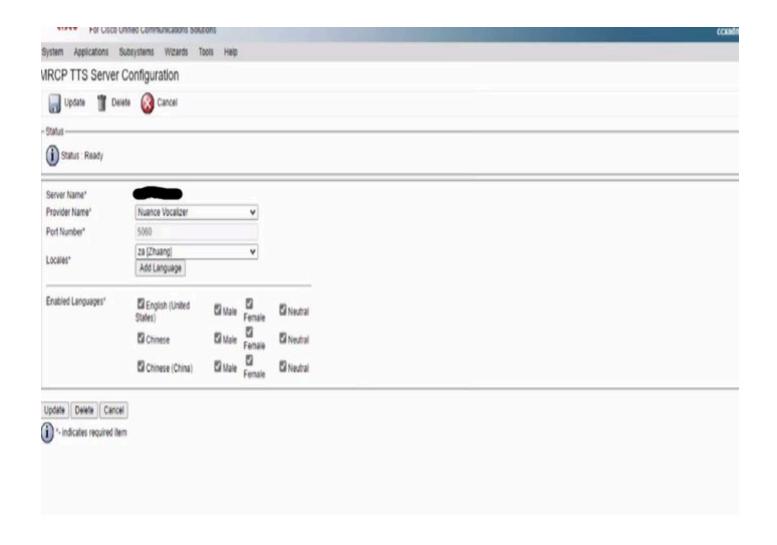
In the MRCP message, you see the speech language as en-us instead of zh_CN. This is because the language code Zh which is base language code for chinese wasn't added to the TTS server configuration on CCX.

Added ZH identified as Chinese in the enabled language section

1. On CCX Admin page, navigate to the MRCP TTS server configuration.

- 2. Under Locales look for Zh and add language for the same.
- 3. Navigate to MRCP TTS default genders and select the defaut gender for the locale added.
