Troubleshoot a UCS C-Series mLOM Card that Cannot Communicate with the CIMC

This document describes how to troubleshoot a Cisco UCS C-Series Rack Server mLOM card that is unable to communicate with the CIMC.

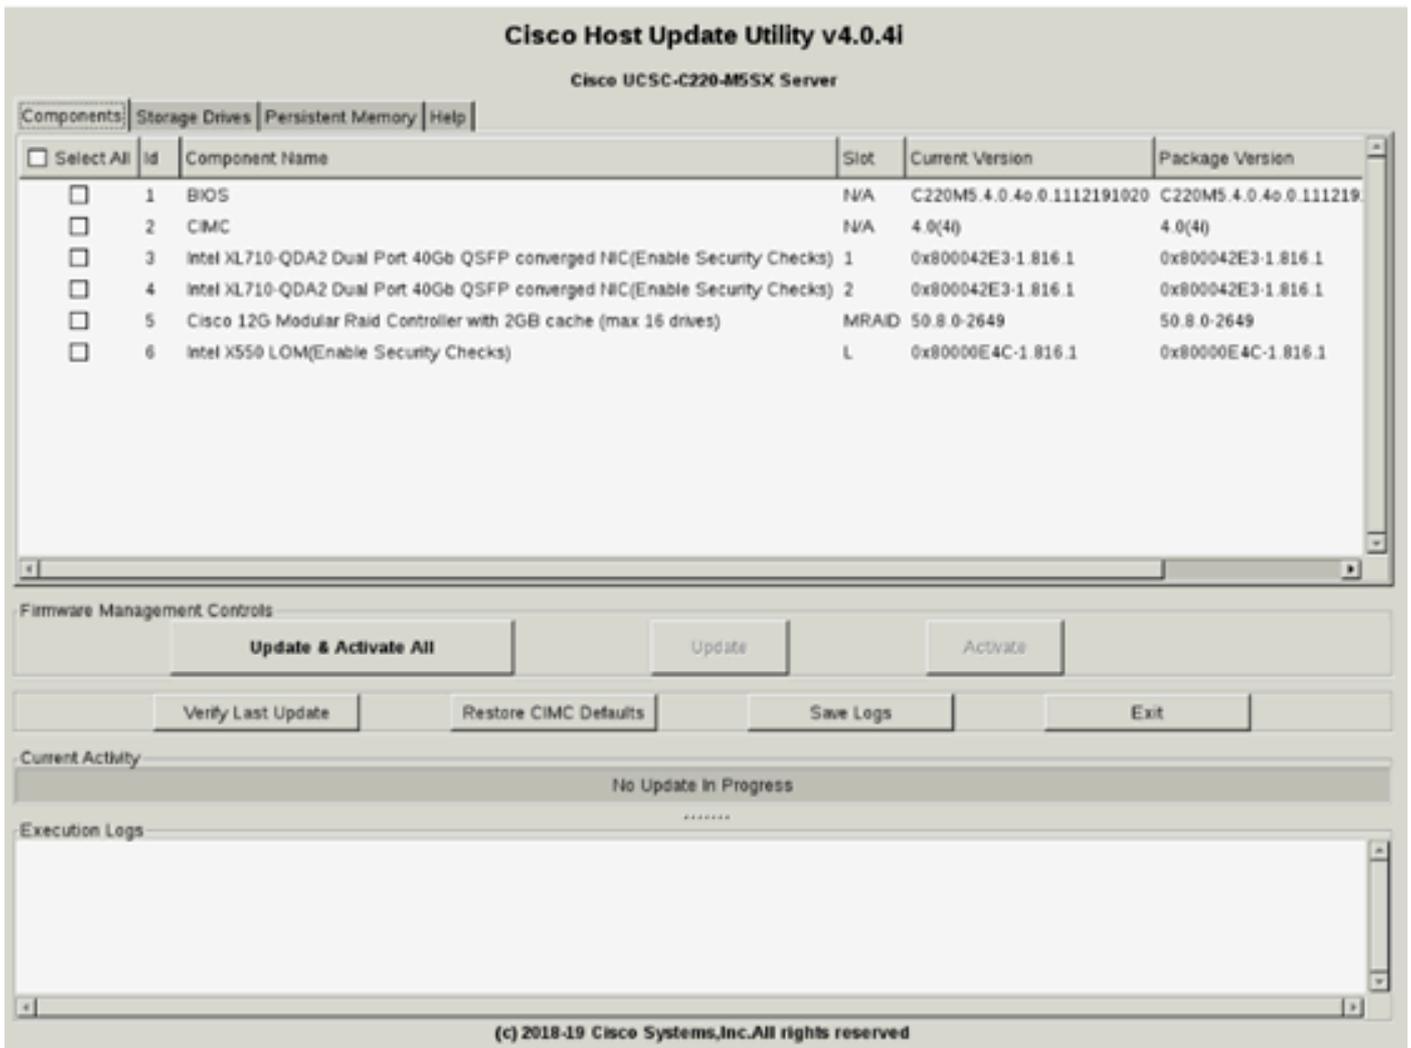
- Check if the Cisco HUU shows the presence of the mLOM card. Here is an example of the Cisco HUU utility not showing the mLOM card.
