# **Troubleshoot Basic Paging Upgrade Error**

This document describes the network card requirements of Cisco Basic Paging Server for an upgrade from version 11.5.1 to version 12.0.1.

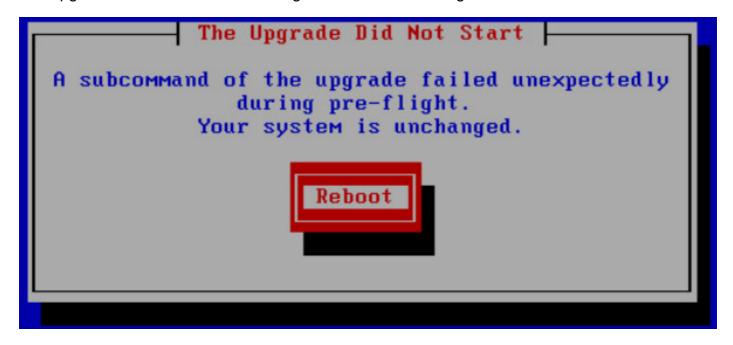
Upgrade of Cisco Basic Paging Server from version 11.5.1 to version 12.0.1 fails with error "A subcommand of the upgrade failed unexpectedly during pre-flight. Your system is unchanged."

The upgrade fails with the error message as shown in the image here:

Power down the Cisco Basic Paging 11.5.1 server and change the network adapter type to E1000 and re-run the upgrade.

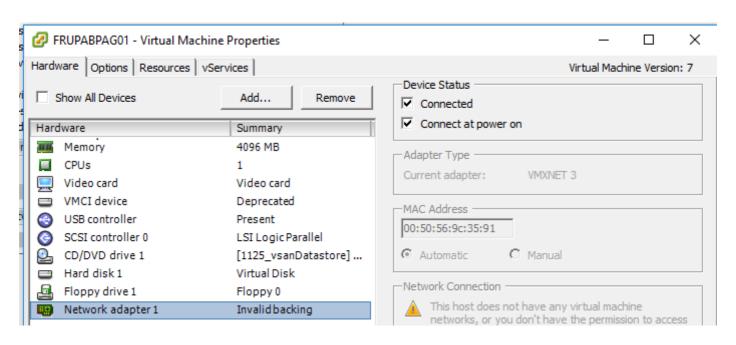
Step 3. Confirm the current network card enabled on the Cisco Basic Paging 11.5.1 server is VMXNET3

As Cisco Basic Paging server 12.0.1 does not support VMXNET3 network card, the upgrade fails at the upgrade-pre-flight check stage.
