排除Multipod PBR上的IP SLA故障

本文檔介紹使用ACI PBR Multipod環境在遠端POD上辨識和排除IP SLA跟蹤裝置的故障的步驟。

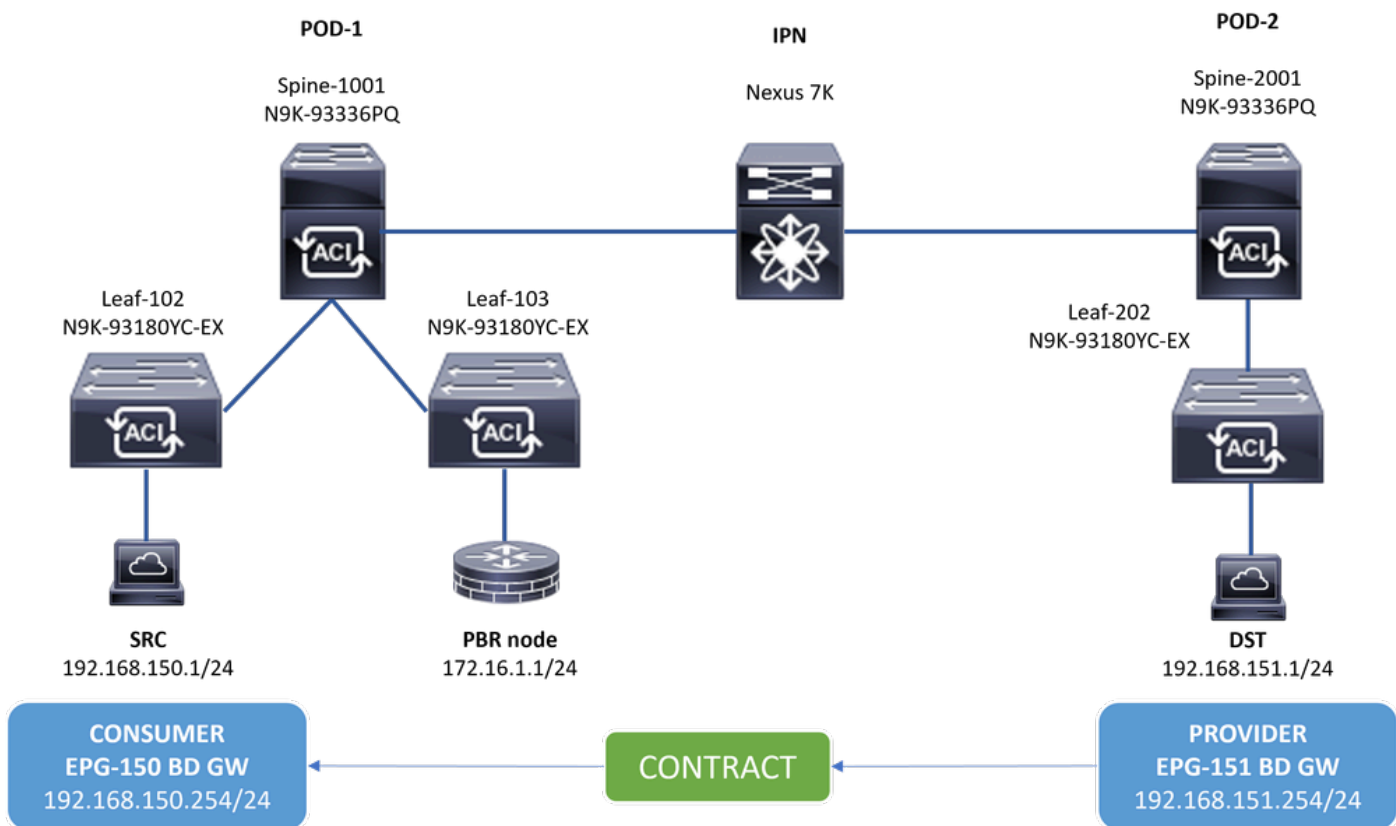
拓撲

在本示例中，在POD-1上的源端點192.168.150.1與POD-2上的目標伺服器192.168.151.1之間無法完成東-西連線。流量從POD-1上的服務枝葉103重定向到PBR節點172.16.1.1。PBR正在使用IP SLA監控和重定向運行狀況組策略。
