Troubleshoot a UCS C-Series mLOM Card that Cannot Communicate with the CIMC

This document describes how to troubleshoot a Cisco UCS C-Series Rack Server mLOM card that is unable to communicate with the CIMC.

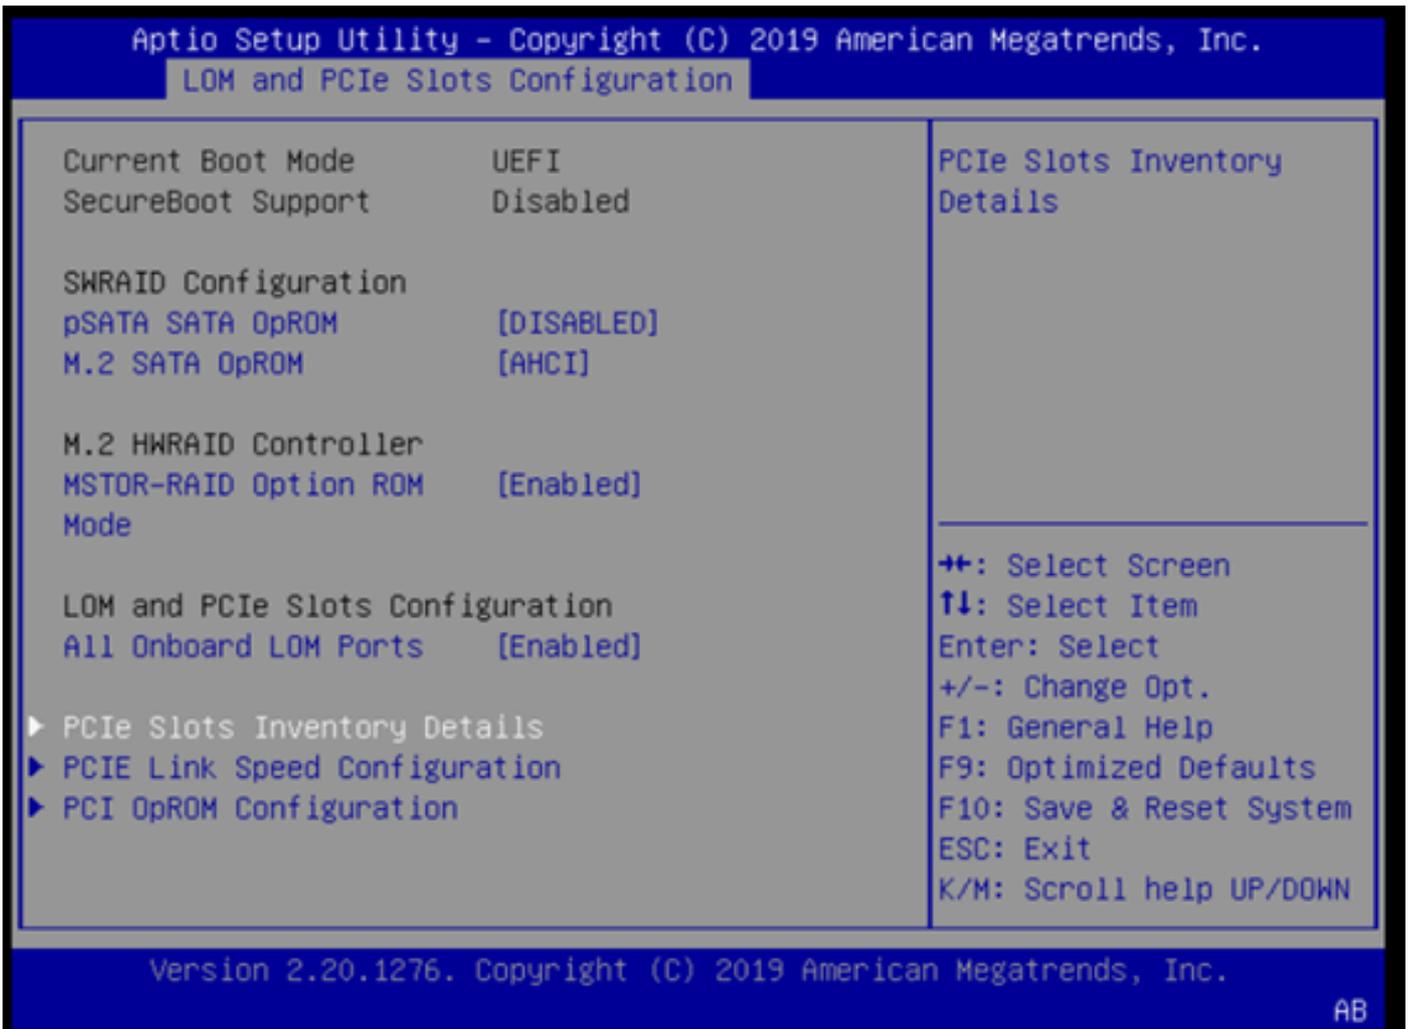
Step 2.2. In the BIOS menu, navigate to Advanced LOM and PCI options, and ensure that **All Onboard LOM Ports** are enabled.
