Replace a Supervisor Module or Stack Member of Catalyst 9000 in HA

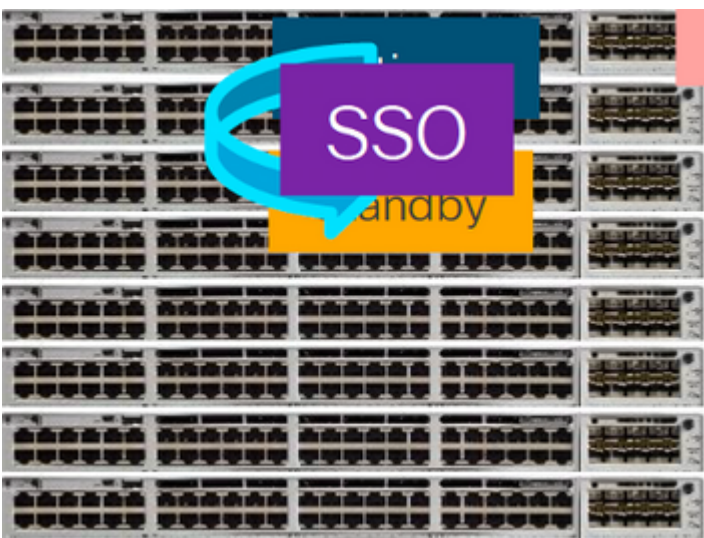
In this example, you **replace a member** of a C9300 stack. (The switch is in this example uses switch 2 in "Install" boot mode).

Note: The same process can be used for the replacement of a **C9200** stack member.

Check that the stack is physically connected in **full-ring**, i.e if you power off the switch member in question, then existing stack would not split to cause **stack-merge**. Once verified, move to next steps.
