Upgrade Cisco Interface Module for LoRaWAN IXM using the Console

This document describes the procedure to upgrade the software of a Cisco IoT Extension Module (IXM) using only the console port and a USB drive.

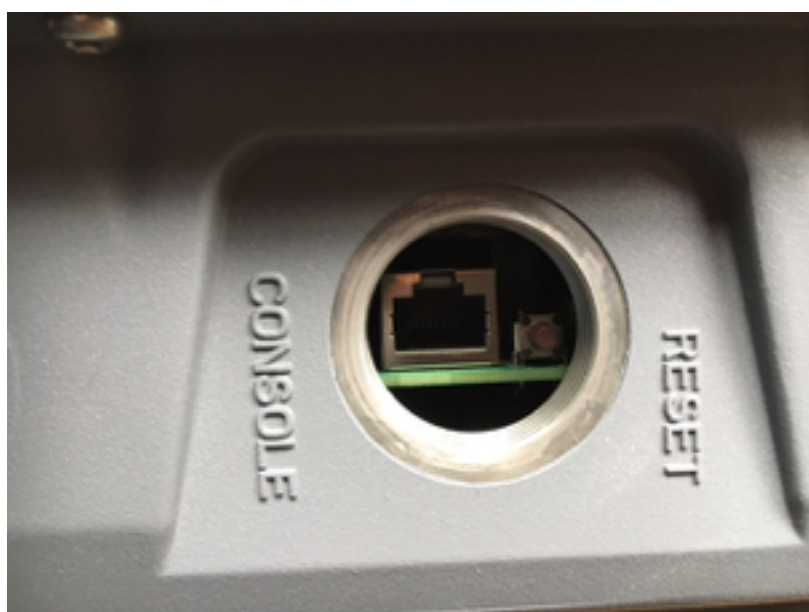
Once the files to perform the upgrade are prepared, you need to connect to the IXM using the console port. The console port is located on the right side of the IXM and is covered by a water proof screw:

Connect the console cable to the RJ45 at the IXM and to the serial port of your PC and open a terminal with these settings: 8/N/1/115200
