Cisco Nexus 5500 Series NX-OS Software Upgrade and Downgrade Guide, Release 7.3(13)N1(1)

This document describes how to upgrade or downgrade Cisco NX-OS software on Cisco Nexus devices and Cisco Nexus Fabric Extenders. Use this document in combination with documents listed in the [“Communications, Services, and Additional Information”](#) section on page 54.

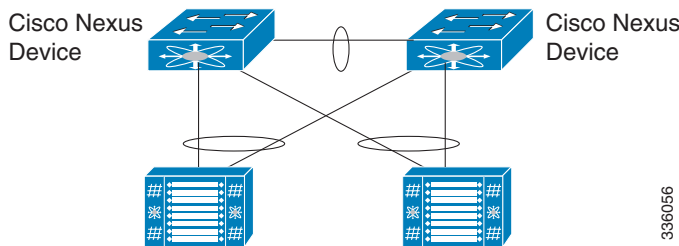
336056

Figure 18 *Cisco Nexus Device Connected to Downstream Switches*
