Cisco Nexus 5600 Series NX-OS Software Upgrade and Downgrade Guide, Release 7.3(9)N1(1)

This document describes how to upgrade or downgrade Cisco NX-OS software on Cisco Nexus devices and Cisco Nexus Fabric Extenders. Use this document in combination with documents listed in the [“Communications, Services, and Additional Information”](#) section on page 56.

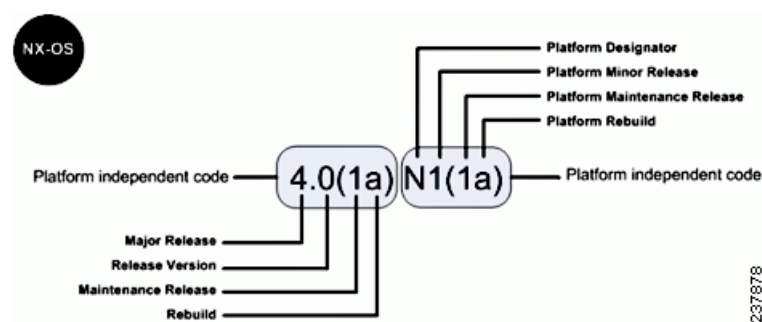
Figure 1 Cisco NX-OS Version Identifies

The platform designator is N for the Nexus Series Switches, E for the Nexus 4000 Series Switches, and S for the Nexus 1000 Series Switches. Applicable features, functions, and fixes in the platform-independent code are present in the platform-dependent release.

The Cisco NX-OS software consists of the kickstart image and the system image. The system image includes the software for the Cisco Nexus device and the Cisco Nexus Fabric Extenders (FEXs) that are connected to the switch. The images contain a major release identifier, a minor release identifier, and a maintenance release identifier, and they can also contain a rebuild identifier, which may also be referred to as a support patch. The following figure shows the version identifiers that are used with a combination of platform-independent and platform-dependent schemes for the Cisco NX-OS software.

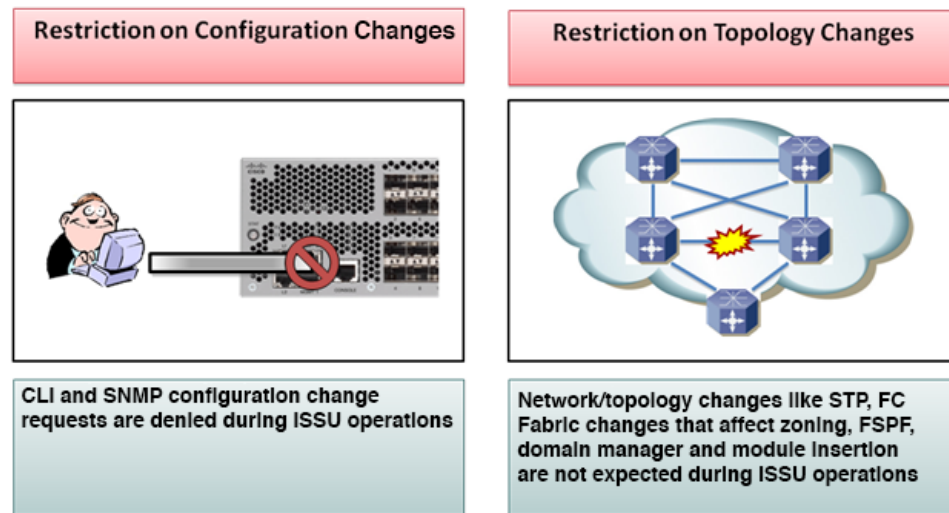
23789-1

The following figure shows upgrade restrictions.

Figure 15 Upgrade Restrictions
