Release Notes for Cisco Aironet Access Points for Cisco IOS Release 12.3(8)JEC2

October 31, 2008

These release notes describe caveats and features for maintenance release Cisco IOS Release 12.3(8)JEC2. This release supports 16-Mb Cisco autonomous access points, including Cisco Aironet 1100, 1200, and 1230 series autonomous access points. The Cisco Aironet 350 series is no longer supported in this release or any future release.

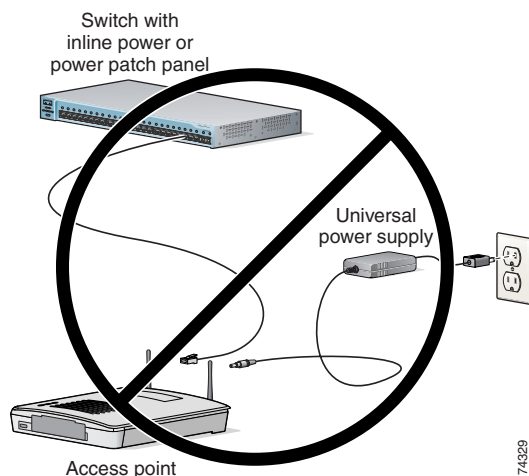
Figure 1 *Improper Power Configuration Using Two Power Sources*

You cannot provide redundant power to 1100 and 1200 series access points with both DC power to its power port and inline power from a patch panel or powered switch to the access point Ethernet port. If you apply power to the access point from both sources, the switch or power patch panel might shut down the port to which the access point is connected. [Figure 1](#) shows the power configuration that can shut down the port on the patch panel or powered switch.
