M.2 Firmware Upgrade with Host Upgrade Utility

Introduction

This document describes how to perform M.2 drive firmware upgrade when M.2 drive firmware on Unified Computing System Manager (UCSM) gets stuck when activated. This issue arises when combined UCS and Hyperflex (HX) upgrade is performed from HX Connect and it happens only in scenarios where the M.2 drive running firmware is D0MU049 and it is upgraded to firmware D0MH072.

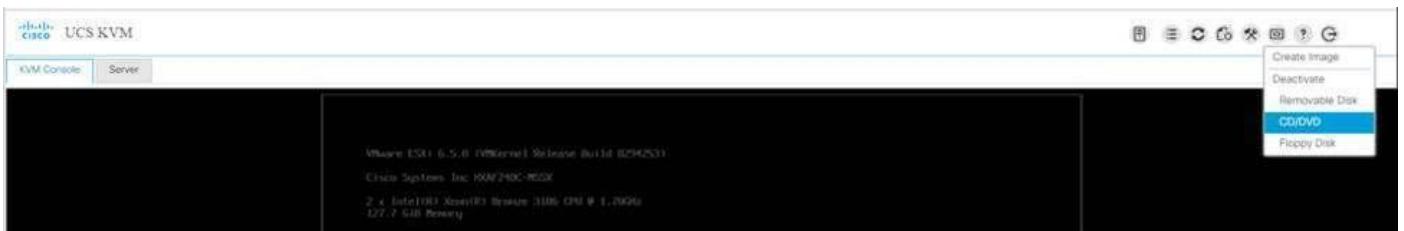
Step 4. Open Keyboard/Video/Mouse (KVM) to the server that you would like to upgrade the M.2 firmware on and Map HUU via Virtual Media.

Activate Virtual Media as shown in the image.

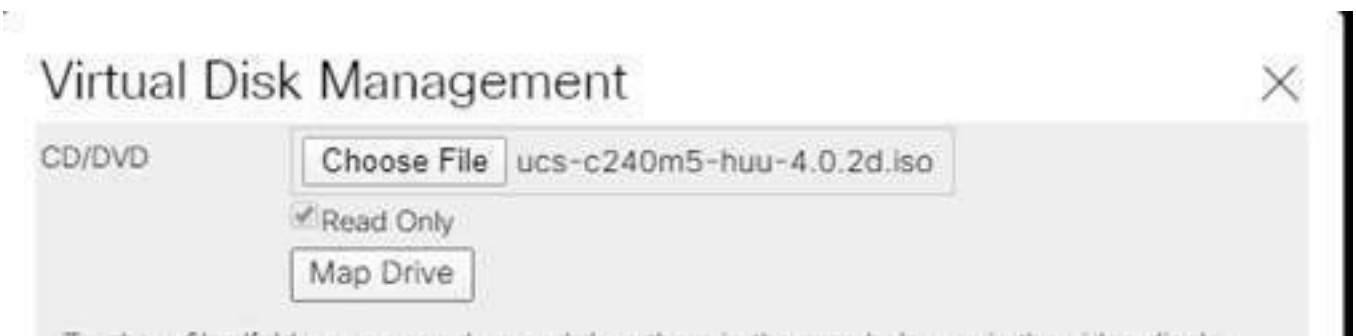
Select HUU and click **Map Drive**.

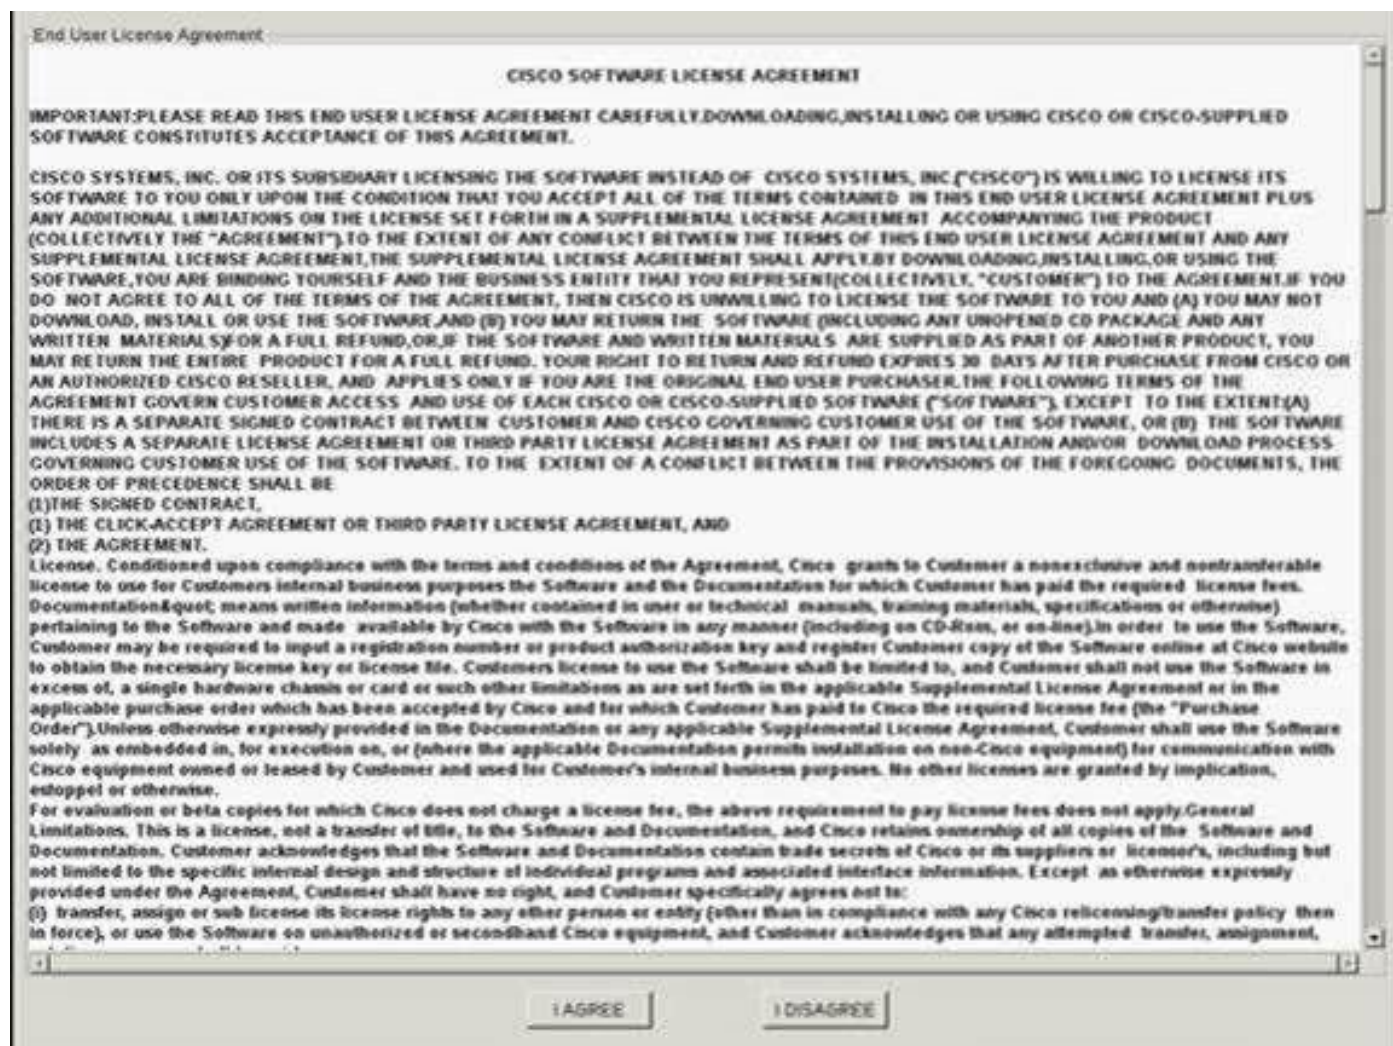
Step 7. Once the HUU loads successfully, you need to acknowledge the End User License Agreement.

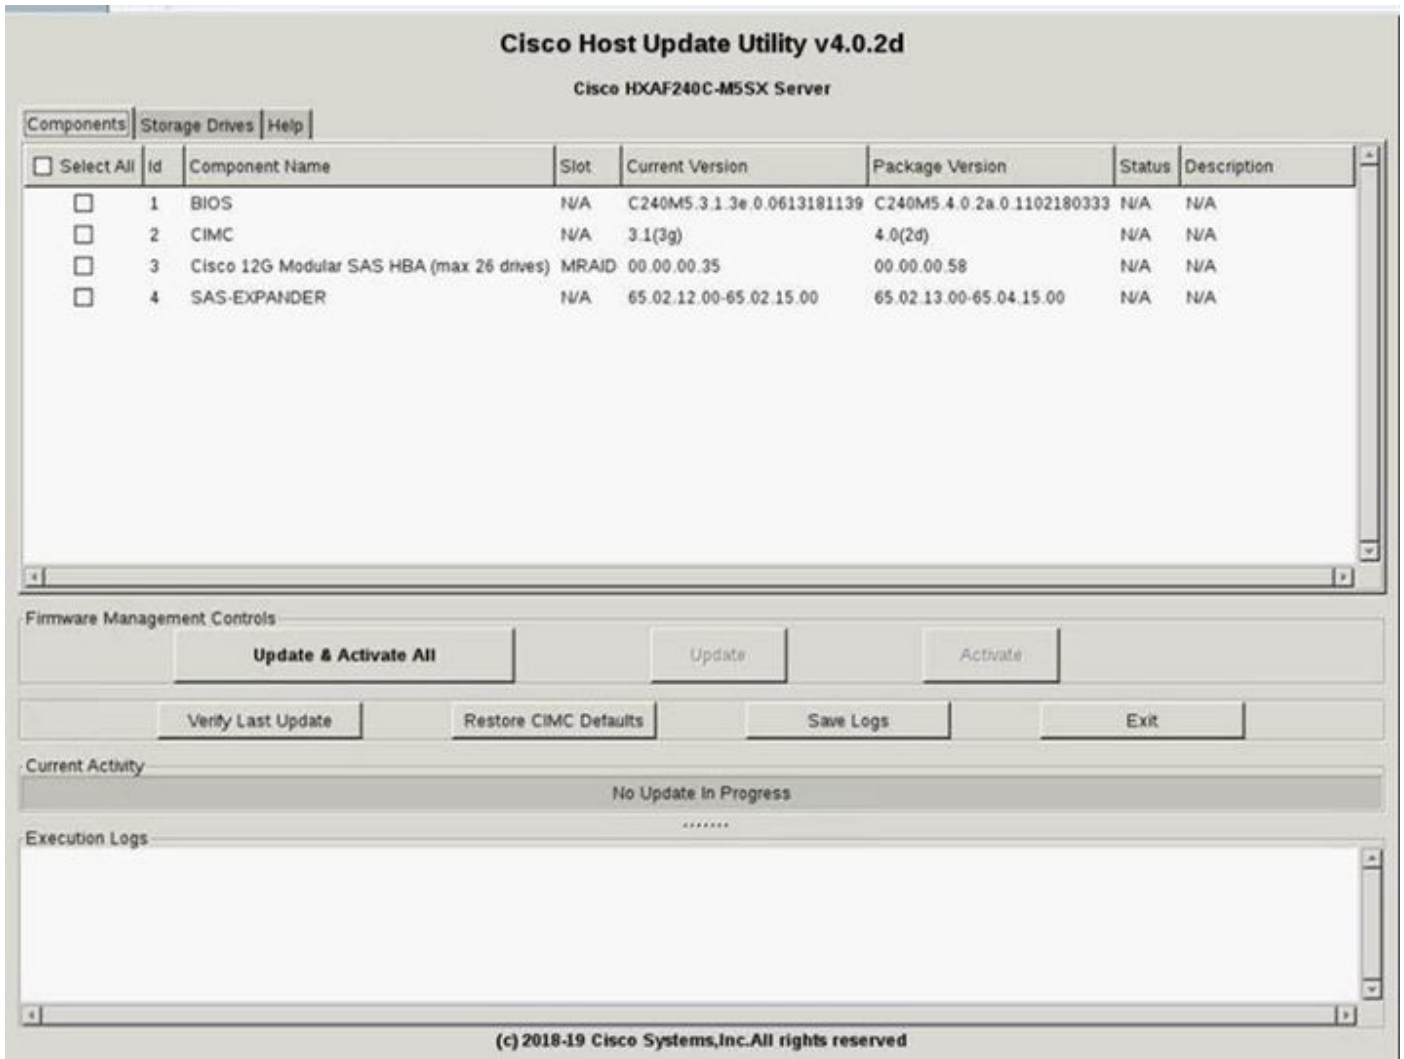
Step 8. The server will discover all the components and you should see all the components once complete.

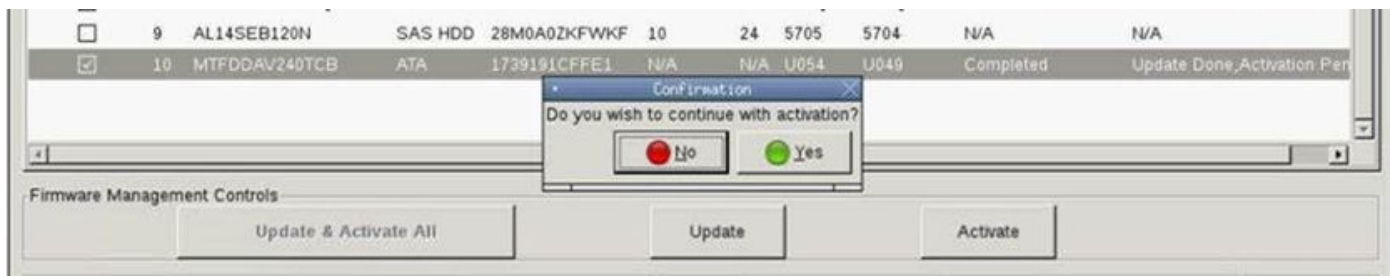
Step 9. Select M.2 drive and click **Activate**. Hit **Yes** in order to proceed with the activation process as shown in the image.

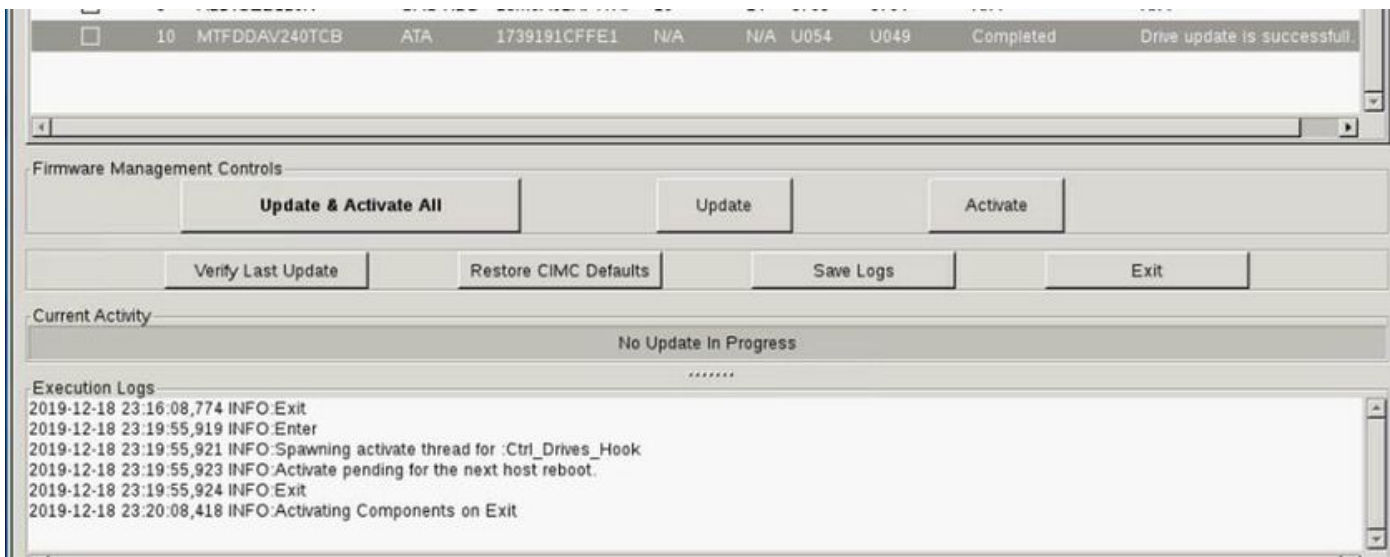
The system will report a successful update process as shown in the image.

Step 10. Select **Exit** in order to activate the new firmware on the M.2 drive. The system should reload automatically. Un-map the HUU from the KVM session. The system should boot successfully to the operating system.
