Troubleshooting Guide for Cisco NCS 1020, IOS XR Release 24.3.x

First Published: 2024-09-04

Troubleshooting of Infrastructure Alarms

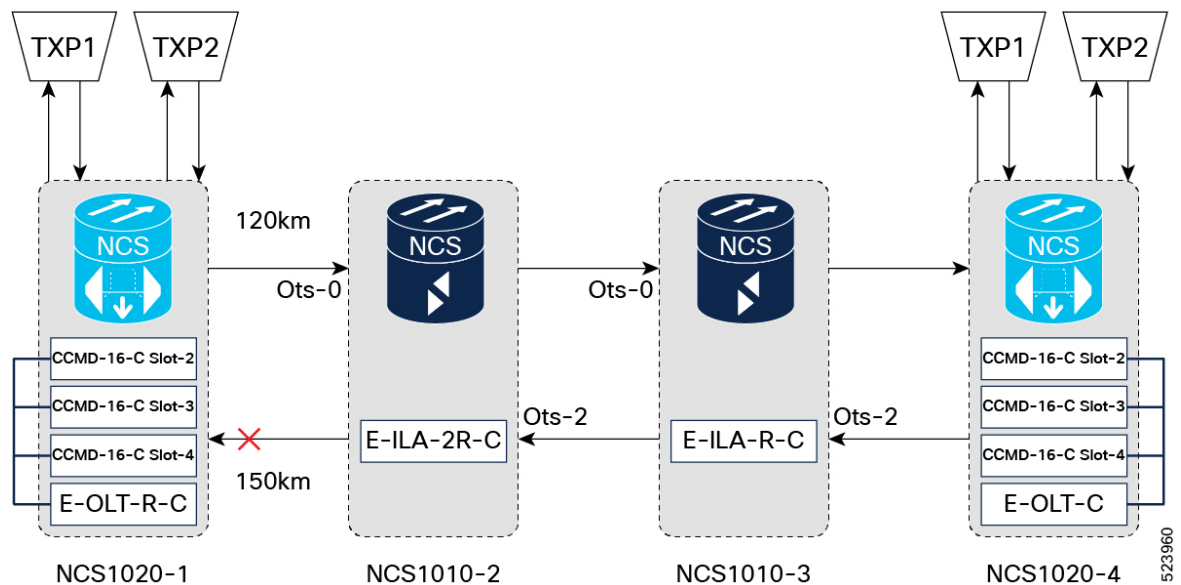
Figure 2: Fiber Cut at the Line OTS Controller

The following figure shows loss of fiber connection continuity at the Line port:

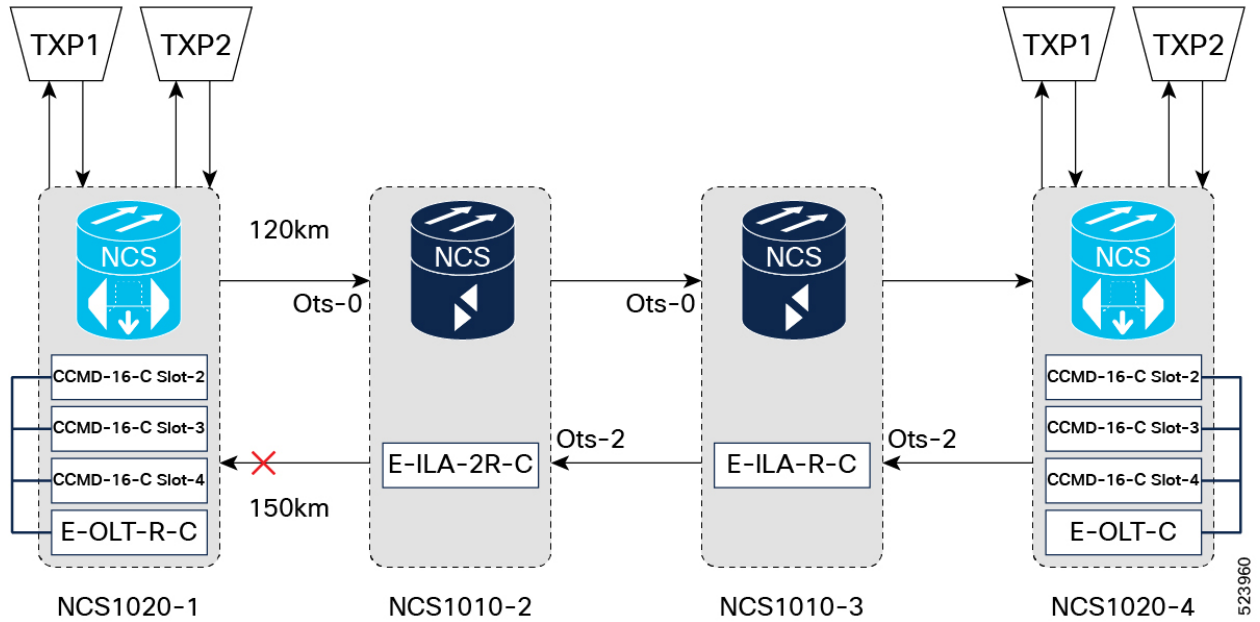
Figure 3: Unidirectional Fiber Cut on Line

The following figure displays line unidirectional fiber cut on a NCS 1020:

The following table lists the alarms that are raised and suppressed at the respective ports of each node:

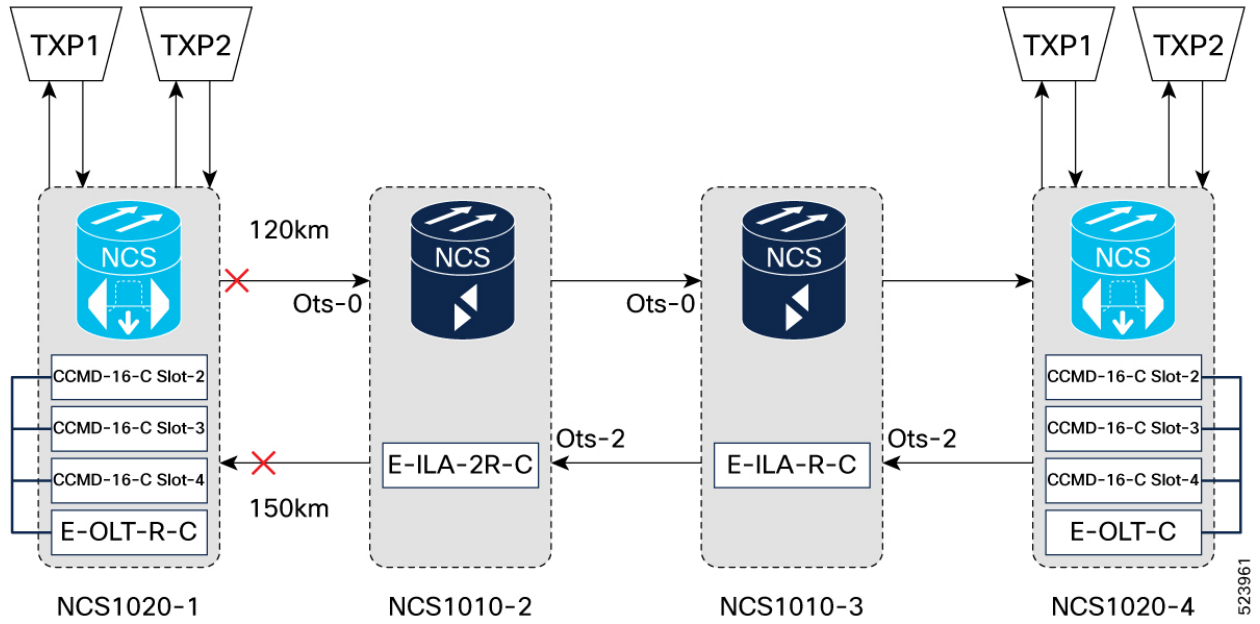
Figure 4: Bidirectional Fiber Cut on Line

The following figure displays line bidirectional fiber cut on a NCS 1020 network:

The following table lists the alarms that are raised and suppressed at the respective ports of each node:

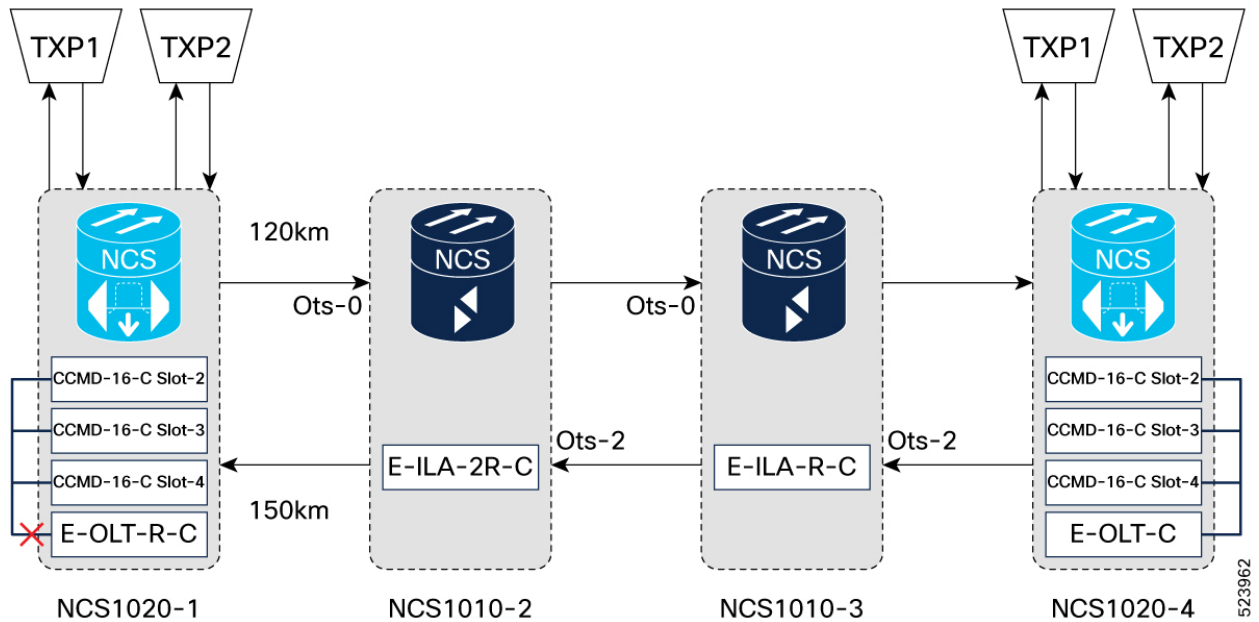
Figure 5: Fiber Cut Between CCMD and OLT

The following figure displays fiber cut between CCMD and OLT:

The following table lists the alarms that are raised and suppressed at the respective ports of each node:

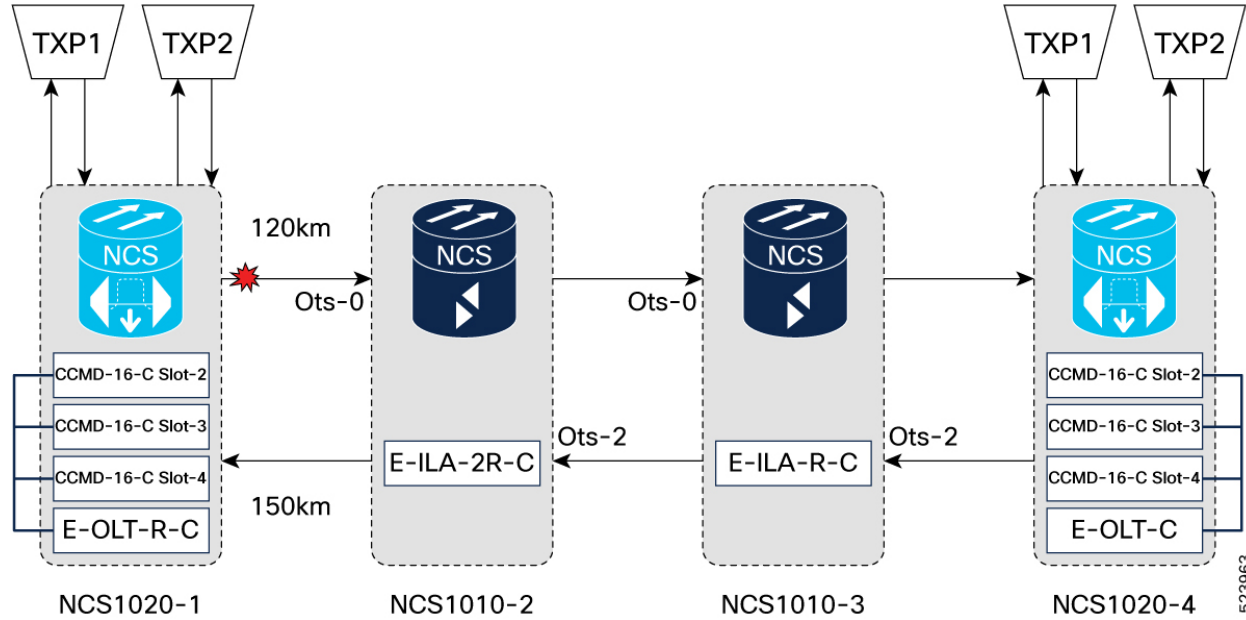
Figure 6: High Back Reflection Condition on the Line Tx port

The following figure displays high back reflection condition on the line Tx port:

The following table lists the alarms that are raised at the respective ports of each node:

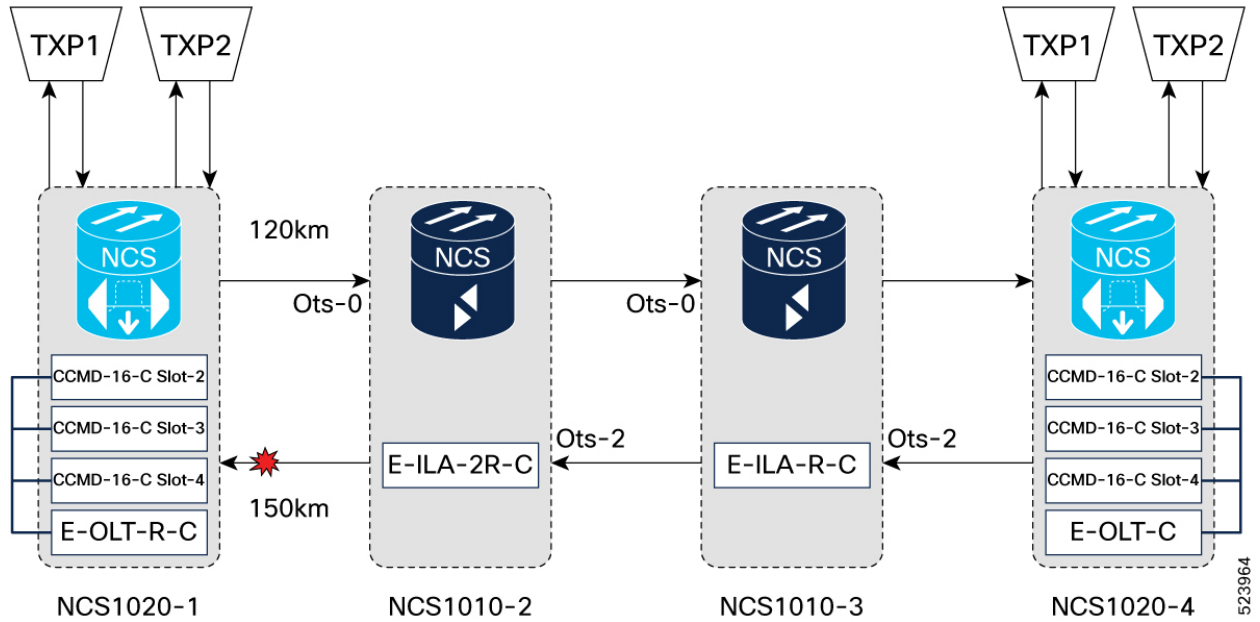
Figure 7: High Back Reflection Condition on the Line Rx RAMAN Port

The following figure displays high back reflection condition on the line Rx RAMAN port:

The following table lists the alarms that are raised at the respective ports of each node:

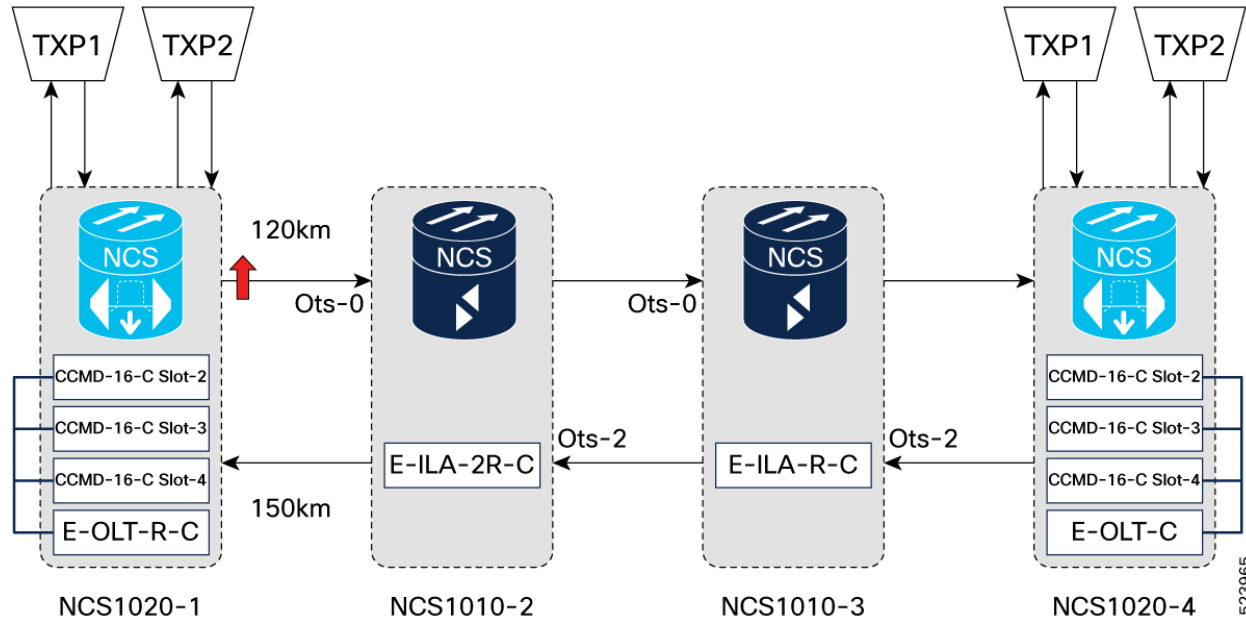
Figure 8: High span loss on Line Tx Port

The following figure displays high span loss on line Tx port:

The following table lists the alarms that are raised at the line Tx port:

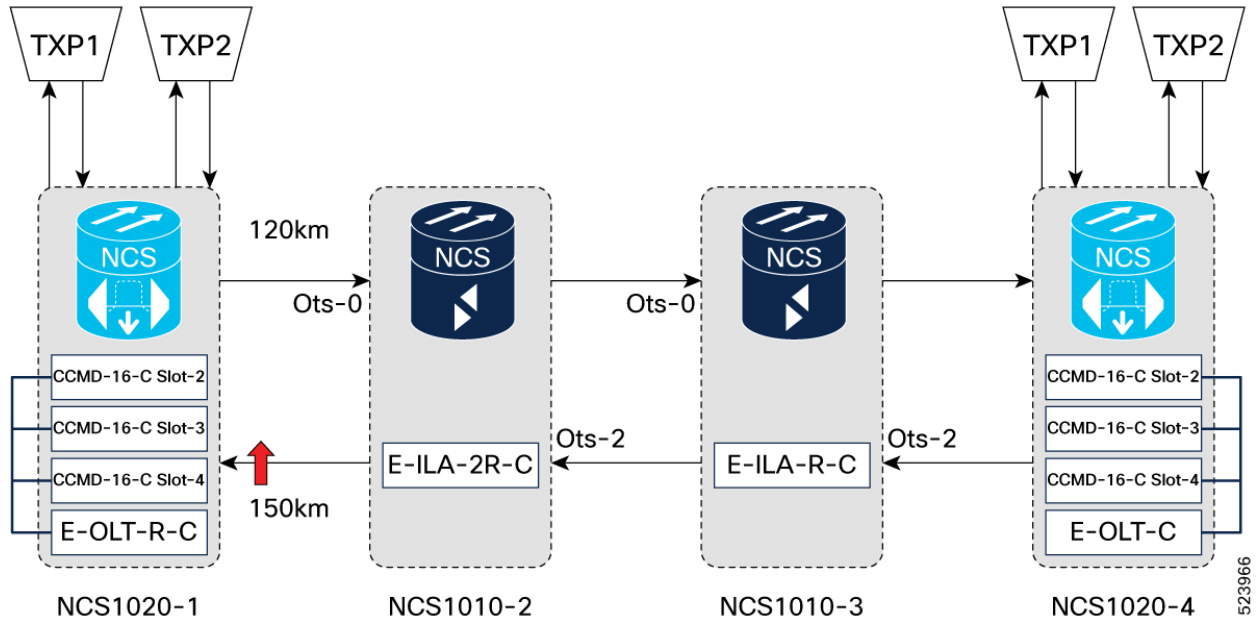
Figure 9: High span loss on Line Rx port

The following figure displays high span loss on the line Rx port:

The following table lists the alarms that are raised at the line Rx port:

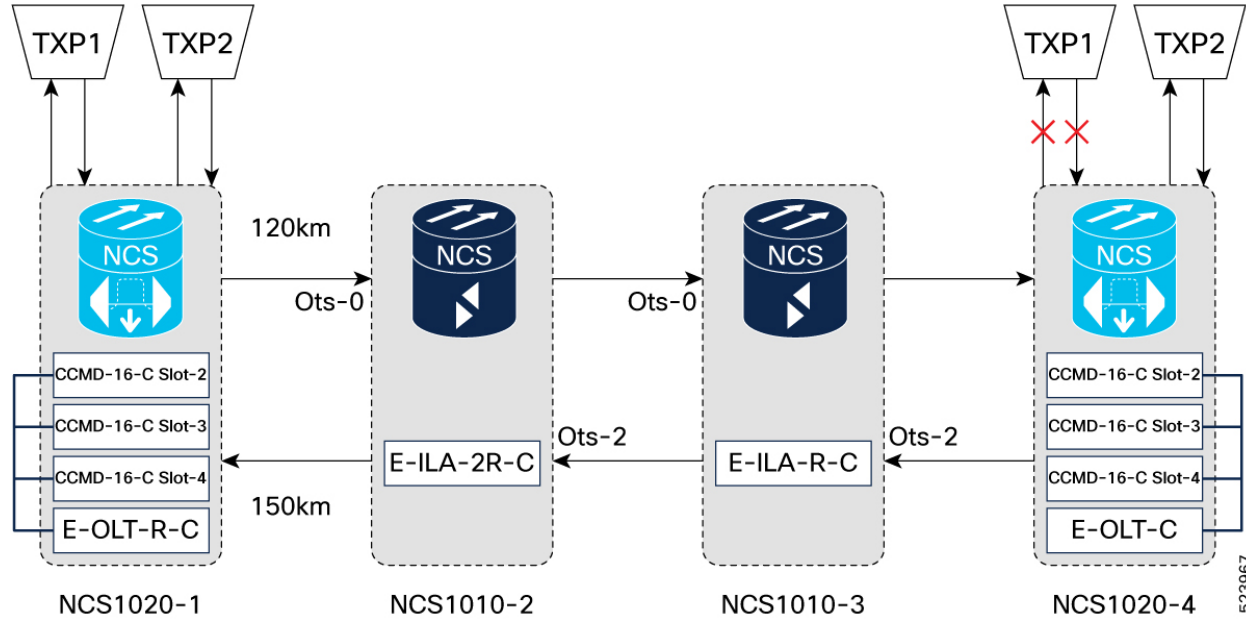
Figure 10: Single Channel Failure due to Bidirectional Fiber Cut on Line

The following figure displays single channel failure due to bidirectional fiber cut on line:

The following table lists the alarms that are raised at the respective ports of each node:

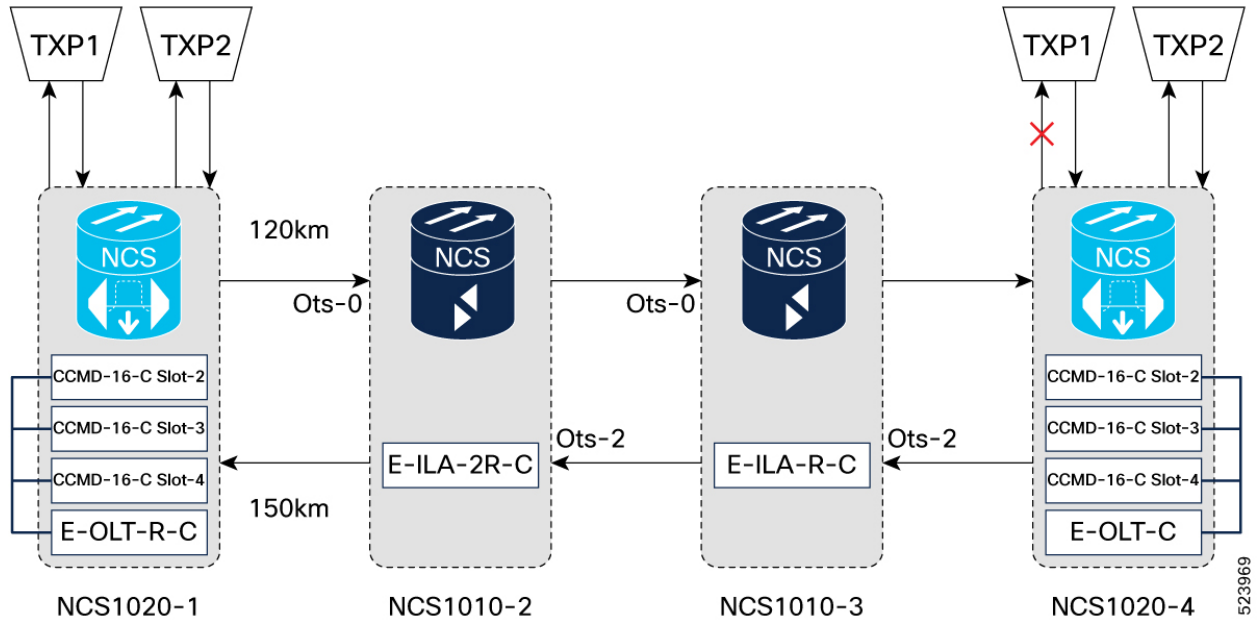
Figure 11: Single Channel Failure due to Unidirectional Fiber Cut at TXP-Tx

The following figure displays single channel failure due to unidirectional fiber cut at TXP-Tx:

The following table lists the alarms that are raised at the respective ports of each node:

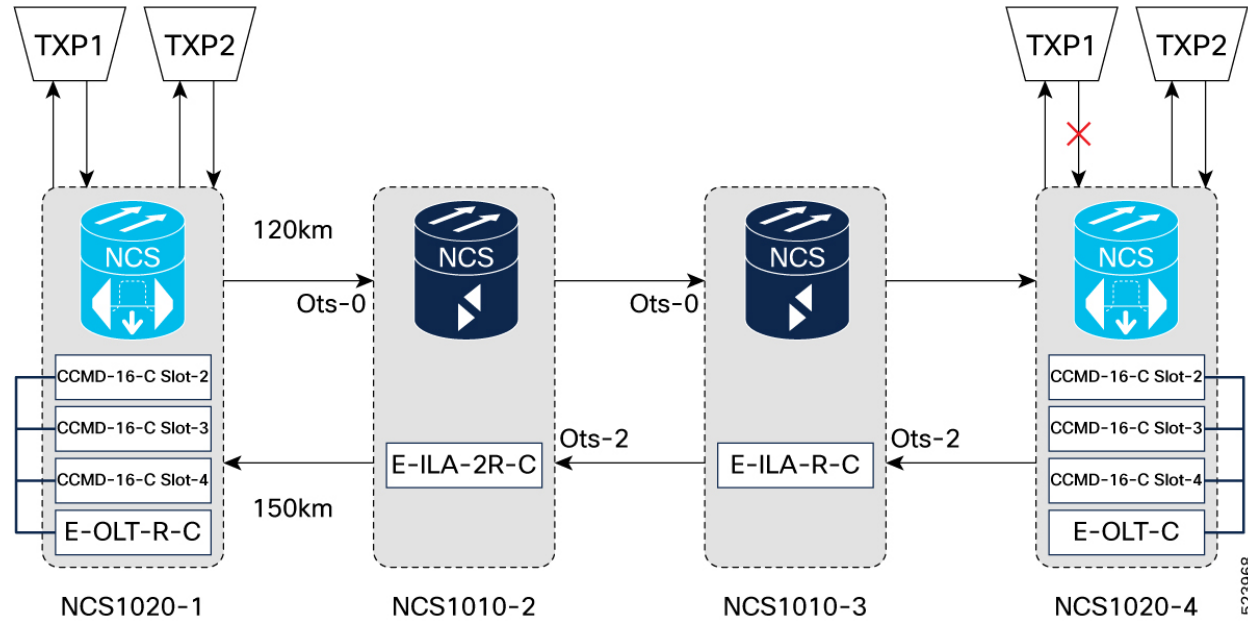
Figure 12: Single Channel Failure due to Unidirectional Fiber Cut at TXP-Tx

The following figure displays single channel failure due to unidirectional fiber cut at TXP-Rx:

NODE	Active Alarms
NCS1020 - 4	No Alarm
NCS1020	No Alarm
