Cisco Nexus 5600 Series NX-OS Software Upgrade and Downgrade Guide, Release 7.0(4)N1(1)

This document describes how to upgrade or downgrade Cisco NX-OS software on Cisco Nexus devices and Cisco Nexus Fabric Extenders. Use this document in combination with documents listed in the [“Obtain Documentation and Submit a Service Request”](#) section on page 47.

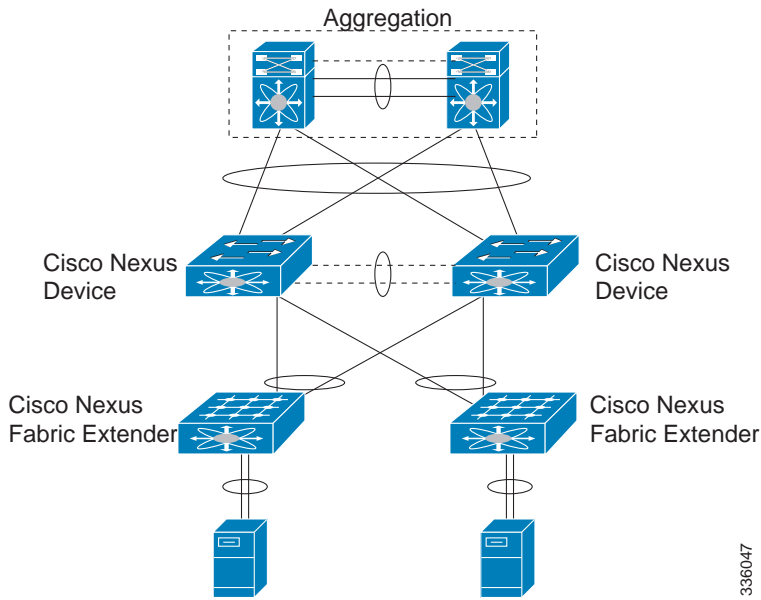
The following figure shows a vPC-peered dual-supervisor virtual modular system with dual-homed FEXs.

Figure 6 *vPC-Peered Dual-Supervisor Virtual Modular System Dual-Homed FEXs*
