Cisco Nexus 6000 Series NX-OS Software Upgrade and Downgrade Guide, Release 7.0(2)N1(1)

This document describes how to upgrade or downgrade Cisco NX-OS software on Cisco Nexus devices and Cisco Nexus Fabric Extenders. Use this document in combination with documents listed in the [“Obtain Documentation and Submit a Service Request”](#) section on page 52.

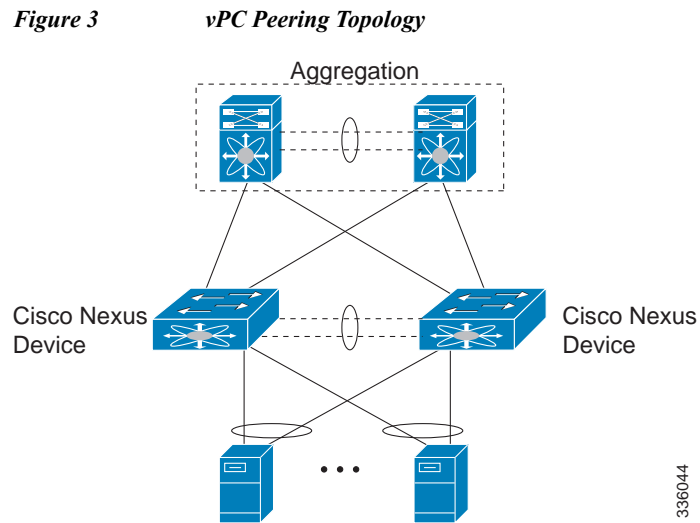
The following figure shows a vPC peering topology.

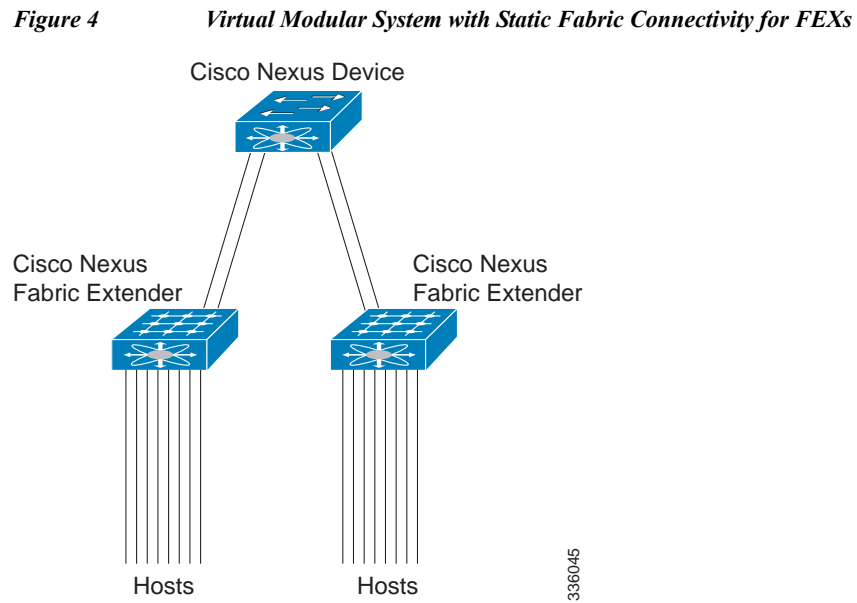
The following figure shows a virtual modular system with static fabric connectivity for FEXs.

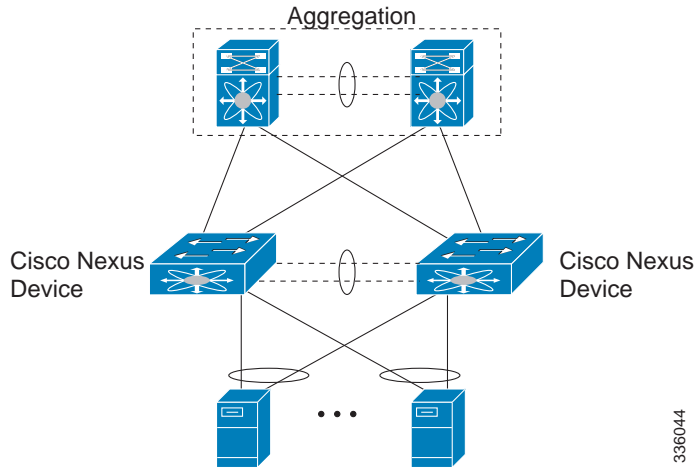
Figure 16 *Hosts Directly Connected to vPC Peers*

The following figures show topologies in which the access layer includes a vPC configuration to hosts or downstream switches.

- Upgrade the first vPC switch (vPC primary switch). During this upgrade, the switch is reloaded. When the switch is reloaded, the servers or the downstream switch detects a loss of connectivity to the first switch and starts forwarding traffic to the second (vPC secondary) switch.
- Verify that the upgrade of the switch has completed successfully. At the completion of the upgrade, the switch restores vPC peering, connected Nexus 2000 Fabric Extenders, and all the links.
- Upgrade the second switch. Repeating the same process on the second switch causes the second switch to reload during the upgrade process. During this reload, the first (upgraded) switch forwards all the traffic to/from servers.
- Verify that the upgrade of the second switch has completed successfully.
