Cisco Nexus 6000 Series NX-OS Software Upgrade and Downgrade Guide, Release 7.0(7)N1(1)

This document describes how to upgrade or downgrade Cisco NX-OS software on Cisco Nexus devices and Cisco Nexus Fabric Extenders. Use this document in combination with documents listed in the [“Obtain Documentation and Submit a Service Request”](#) section on page 52.

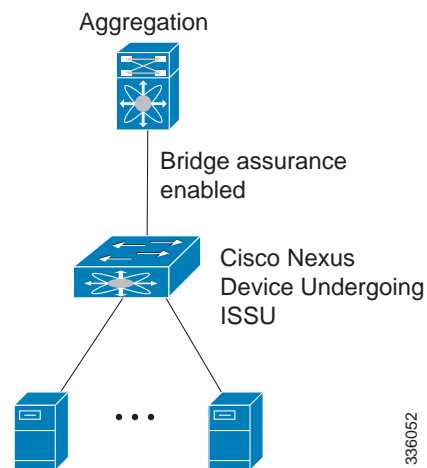
The following figure shows a Cisco Nexus device that is running Bridge Assurance with another switch.

Figure 11 *Cisco Nexus Device Running Bridge Assurance with Another Switch*
