Upgrading the Cisco cBR Series Converged Broadband Routers for Cisco IOS XE Gibraltar 16.12.x

First Published: 2019-07-18

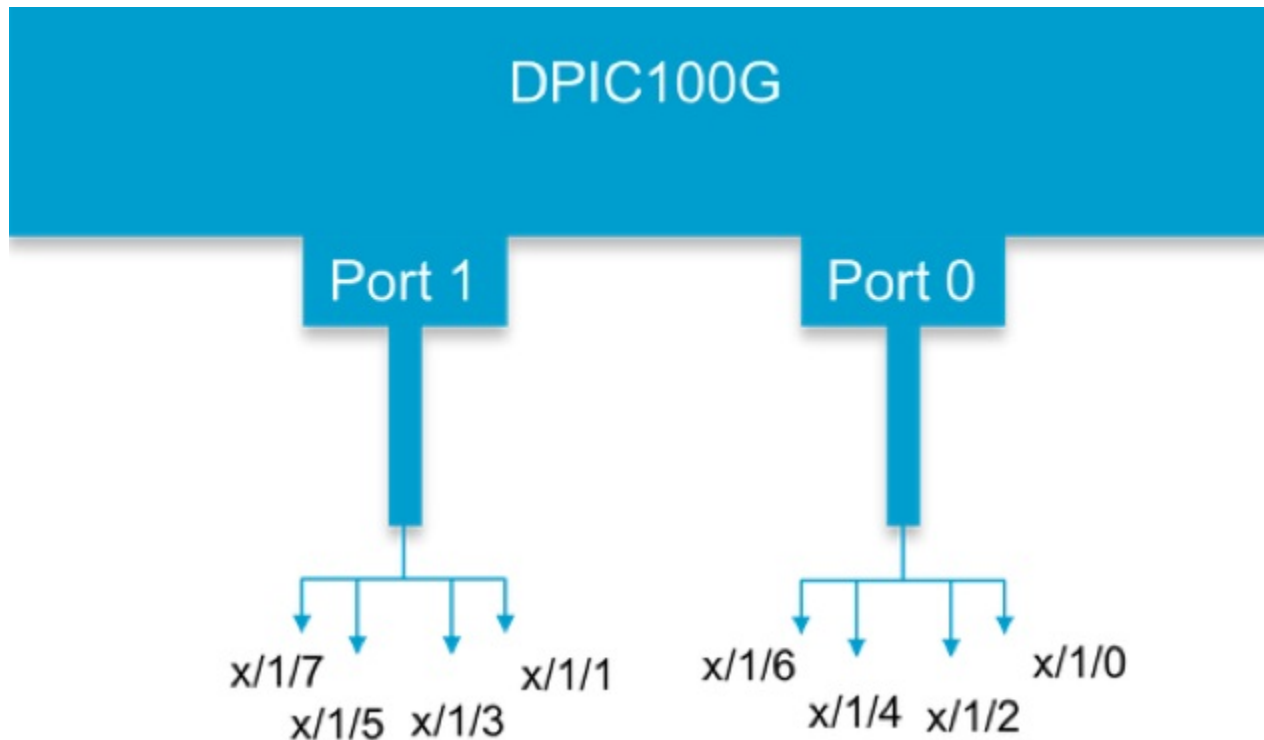
Step 9 Connect original fibers to breakout cable with butt joint. Port mapping: the first port is mapped to TenGiga 0, 2, 4, 6, the second port is mapped to TenGiga 1, 3, 5, 7.

Note DPIC 100G board silk print has wrong port number shown on board. The right ports number are as follows.

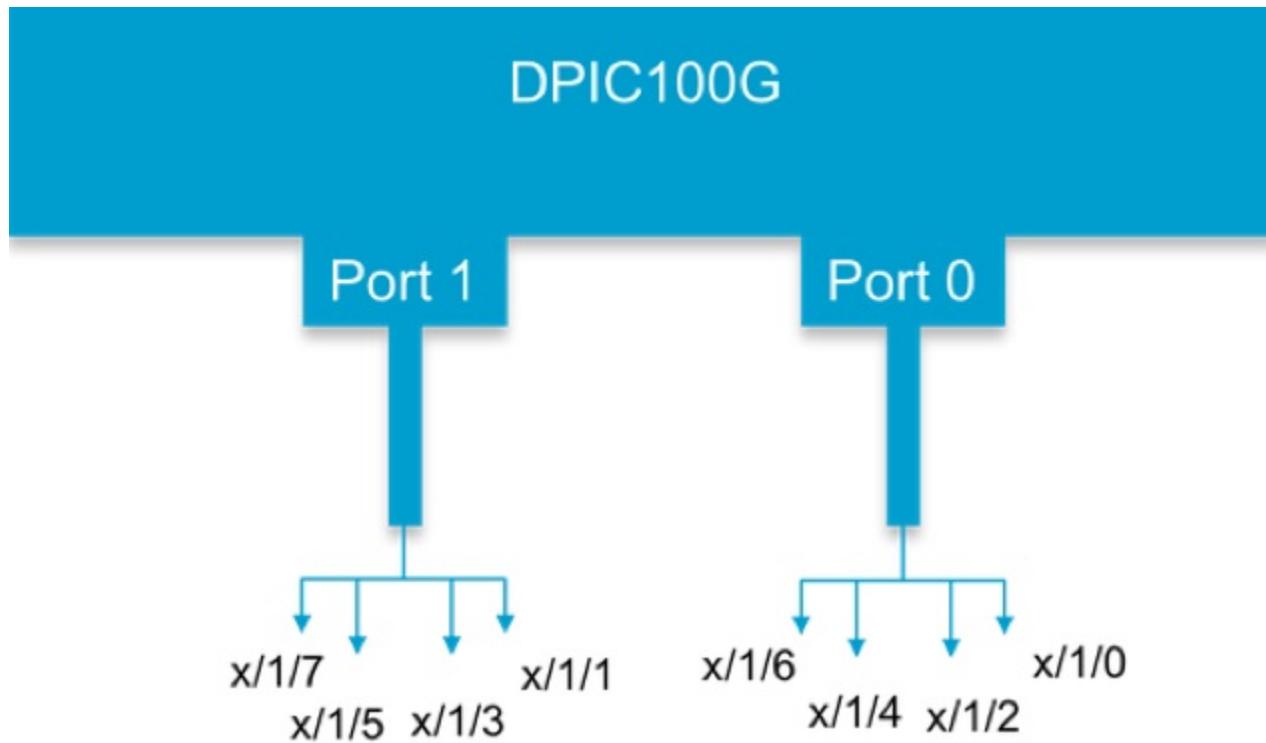
Step 9 Connect original fibers to breakout cable with butt joint. Port mapping: the first port is mapped to TenGiga 0, 2, 4, 6, the second port is mapped to TenGiga 1, 3, 5, 7.

Note DPIC 100G board silk print has wrong port number shown on board. The right ports number are as follows.
