Cisco ONS 15454 Troubleshooting Guide

Product and Documentation Release 4.0

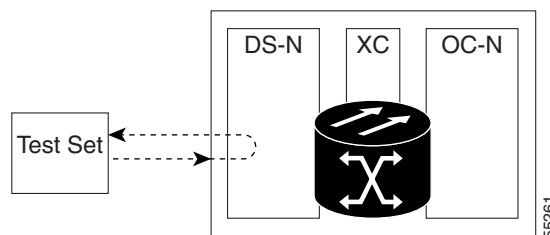
Figure 1-1 Facility Loopback Process on a DS-N Card

A facility loopback tests the line interface unit (LIU) of a card, the EIA (electrical interface assembly), and related cabling. After applying a facility loopback on a port, use a test set to run traffic over the loopback. A successful facility loopback isolates the LIU, the EIA, or cabling plant as the potential cause of a network problem. [Figure 1-1](#) shows a facility loopback on a DS-N card.

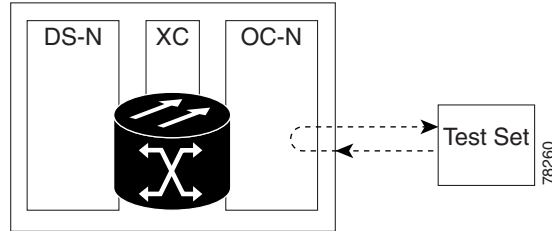
Figure 1-2 Facility Loopback Process on an OC-N Card

To test the LIU on an OC-N card, connect an optical test set to the OC-N port and perform a facility loopback or use a loopback or hairpin on a card that is farther along the circuit path. [Figure 1-2](#) shows a facility loopback on an OC-N card.

Before performing a facility loopback on an OC-N card, make sure the card contains at least two data communications channel (DCC) paths to the node where the card is installed. A second DCC provides a non looped path to log into the node after the loopback is applied, thus enabling you to remove the facility loopback. Ensuring a second DCC is not necessary if you are directly connected to the ONS 15454 containing the loopback OC-N card.

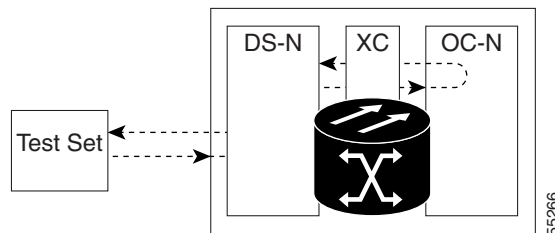
Figure 1-3 The Terminal Loopback Process on an OC-N Card

A terminal loopback tests a circuit path as it passes through the cross-connect card (XC, XCVT, or XC10G) and loops back from the card with the loopback. [Figure 1-3](#) shows a terminal loopback on an OC-N card. The test-set traffic comes in on the DS-N card and goes through the cross-connect card to the OC-N card. The terminal loopback on the OC-N card turns the signal around before it reaches the LIU and sends it back through the cross-connect card to the DS-N card. This test verifies that the cross-connect card and terminal circuit paths are valid, but does not test the LIU on the OC-N card.

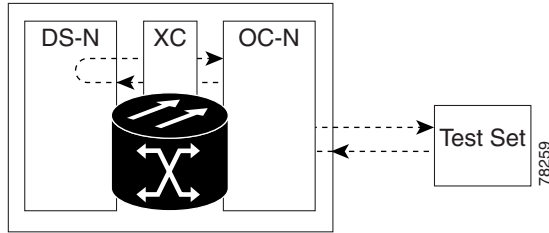
Figure 1-4 The Terminal Loopback Process on a DS-N Card

[Figure 1-4](#) shows a terminal loopback on a DS-N card. The test-set traffic comes in on the OC-N card and goes through the cross-connect card to the DS-N card. The terminal loopback on the DS-N card turns the signal around before it reaches the LIU and sends it back through the cross-connect card to the OC-N card. This test verifies that the cross-connect card and terminal circuit paths are valid, but does not test the LIU on the DS-N card.

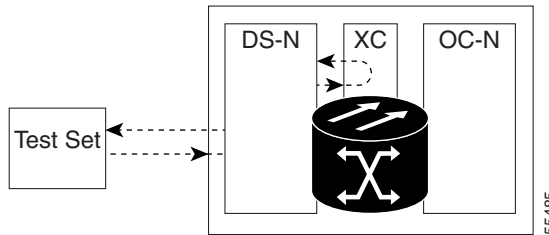
Figure 1-5 The Hairpin Circuit Process on a DS-N Card

A hairpin circuit brings traffic in and out on a DS-N port rather than sending the traffic onto the OC-N card. A hairpin loops back only the specific STS or VT circuit and does not cause an entire OC-N port to loop back, thus preventing a drop of all traffic on the OC-N port. The hairpin allows you to test a specific STS or VT circuit on nodes running live traffic. Figure 1-5 shows the hairpin circuit process on a DS-N card.

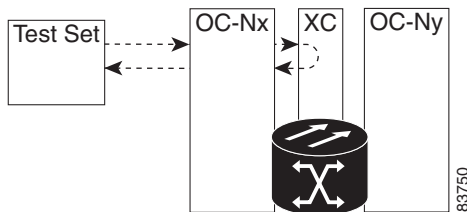
Figure 1-6 The Cross-connect Loopback Process on an OC-N Card

A cross-connect loopback tests a circuit path as it passes through the cross-connect card and loops back to the port being tested. Testing and verifying circuit integrity often involves taking down the whole line; however, a cross-connect loopback allows you to create a loopback on any embedded channel at supported payloads at the STS-1 granularity and higher. For example, you can loop back a single STS-1, STS-3c, STS-6c, etc. on an optical facility without interrupting the other STS circuits. Note the following restrictions to a cross-connect loopback:

Figure 1-6 shows a cross-connect loopback on an OC-N port.

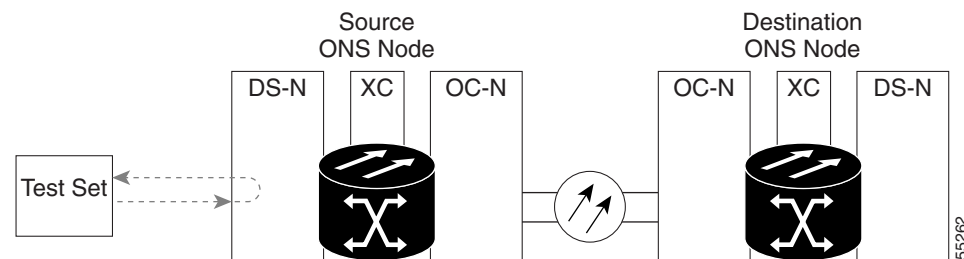
Figure 1-7 A Facility Loopback on a Circuit Source DS-N Port

The facility loopback test is performed on the node source port in the network circuit, in this example, the DS-N port in the source node. Completing a successful facility loopback on this port isolates the cabling, the DS-N card, and the EIA as possible failure points. [Figure 1-7](#) shows an example of a facility loopback on a source DS-N port.

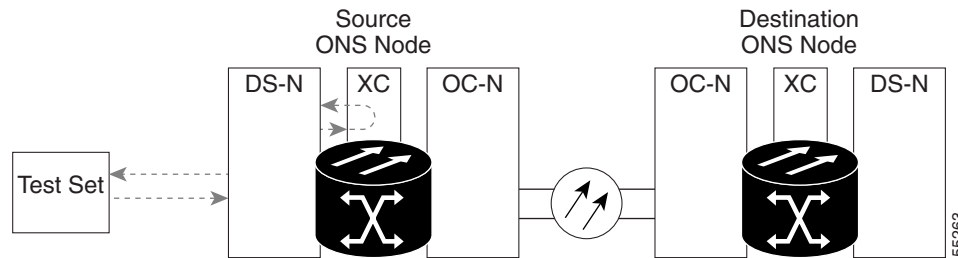
Figure 1-8 Hairpin on a Source Node Port

The hairpin test is performed on the cross-connect card in the network circuit. A hairpin circuit uses the same port for both source and destination. Completing a successful hairpin through the card isolates the possibility that the cross-connect card is the cause of the faulty circuit. [Figure 1-8](#) shows an example of a hairpin loopback on a source node port.

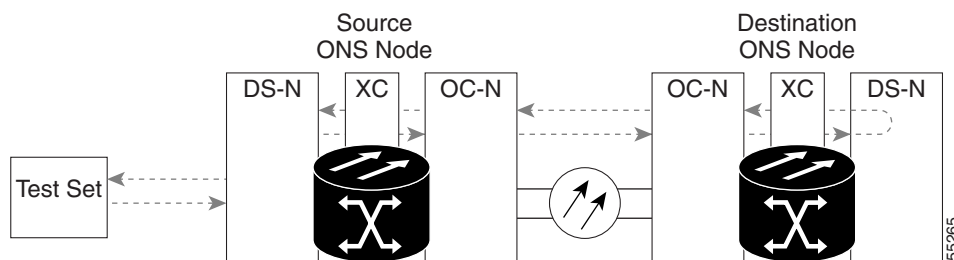
Figure 1-9 Terminal Loopback on a Destination DS-N Port

The terminal loopback test is performed on the node destination port in the circuit, in this example, the DS-N port in the destination node. First, create a bidirectional circuit that starts on the source node DS-N port and loops back on the destination node DS-N port. Then proceed with the terminal loopback test. Completing a successful terminal loopback to a destination node DS-N port verifies that the circuit is good up to the destination DS-N. [Figure 1-9](#) shows an example of a terminal loopback on a destination DS-N port.

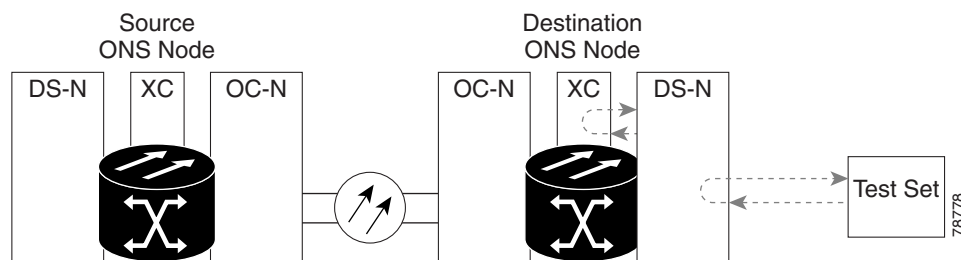
Figure 1-10 Hairpin on a Destination Node

The hairpin test is performed on the cross-connect card in the network circuit. A hairpin circuit uses the same port for both source and destination. Completing a successful hairpin through the card isolates the possibility that the cross-connect card is the cause of the faulty circuit. [Figure 1-8](#) shows an example of a hairpin loopback on a destination node.

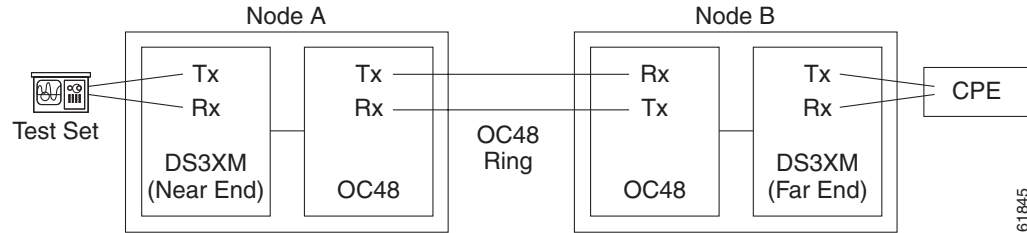
Figure 1-13 Diagram of FEAC

The far end in FEAC refers to the piece of equipment that is connected to the DS3XM-6 card and not the far end of a circuit. In [Figure 1-13](#), if a DS3XM-6 (near-end) port is configured to send a Line Loop Code, the code will be sent to the connected test set, not the DS3XM-6 (far-end) port.

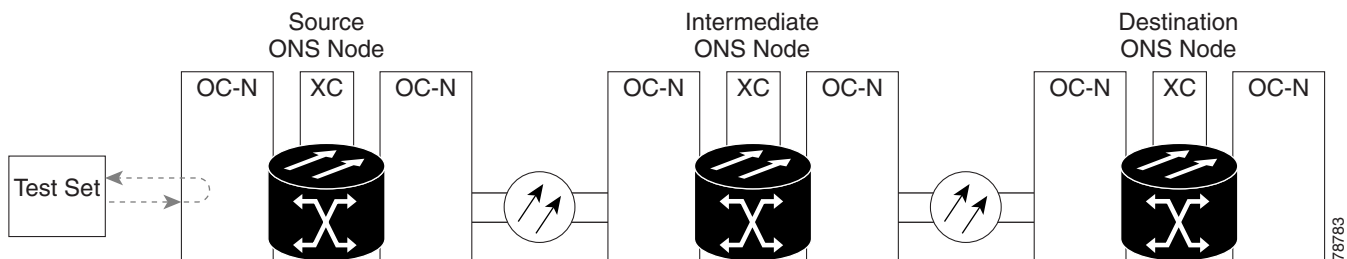
Figure 1-14 Facility Loopback on a Circuit Source OC-N Port

The facility loopback test is performed on the node source port in the network circuit, in this example, the source OC-N port in the source node. Completing a successful facility loopback on this port isolates the OC-N port as a possible failure point. [Figure 1-14](#) shows an example of a facility loopback on a circuit source OC-N port.

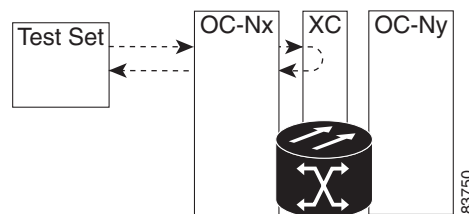
Figure 1-16 XC Loopback on a Source OC-N Port

The XC loopback test occurs on the cross-connect card in a network circuit. An XC loopback circuit uses the same port for both source and destination. Completing a successful XC loopback through the cross-connect card isolates the possibility that the cross-connect card is the cause of the faulty circuit. [Figure 1-16](#) shows an example of an XC loopback on a source OC-N port.

An XC loopback breaks down an existing circuit path and creates a new cross-connect circuit (a hairpin), while the source of the original path is set to inject a line-side AIS-P condition. For instance, if you create an XC loopback from node A to node C through an intermediate node (B), the connection between A and B will be broken. Node C will be left with a one-way hairpin circuit back to A, and node A will inject an AIS-P signal. For more information about this condition, see the “[2.6.3 AIS-P](#)” section on page 2-22.

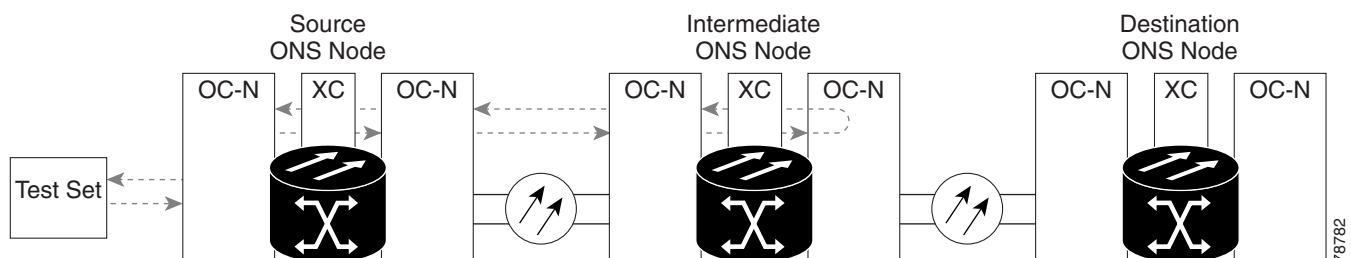
Figure 1-18 Terminal Loopback on an Intermediate-Node OC-N Port

The terminal loopback test is performed on the node destination port in the circuit, in this example, the destination OC-N port in the intermediate node. First, create a bidirectional circuit that starts on the node source OC-N port and loops back on the node destination OC-N port. Then proceed with the terminal loopback test. Completing a successful terminal loopback to a node destination OC-N port verifies that the circuit is good up to the destination OC-N. [Figure 1-18](#) shows an example of a terminal loopback on an intermediate node destination OC-N port.

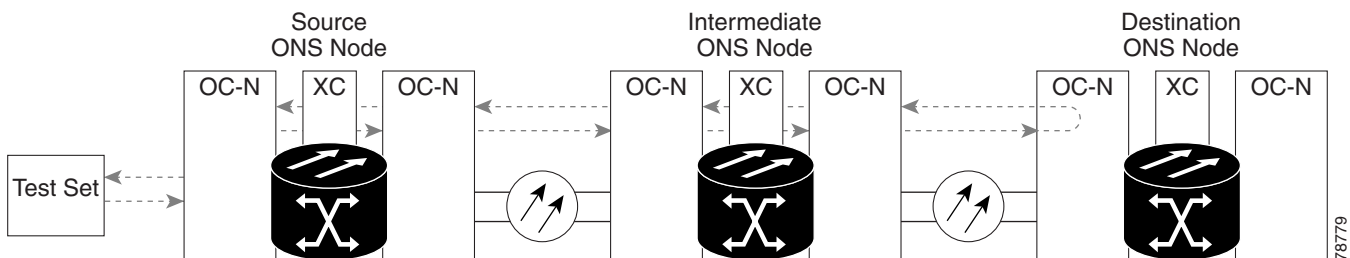
Figure 1-19 Facility Loopback on a Destination Node OC-N Port

The facility loopback test is performed on the node source port in the network circuit, in this example, the source OC-N port in the destination node. Completing a successful facility loopback on this port isolates the OC-N port as a possible failure point. [Figure 1-19](#) shows an example of a facility loopback on a destination node circuit source OC-N port.

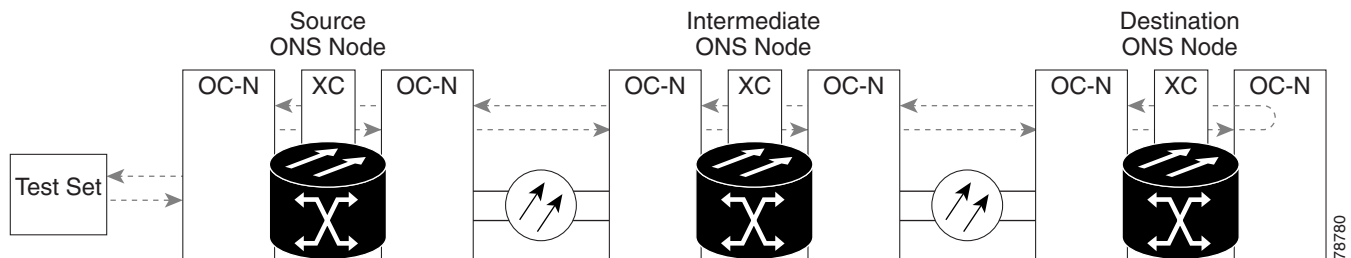
Figure 1-20 Terminal Loopback on a Destination Node OC-N Port

The terminal loopback test is performed on the node destination port in the circuit, in this example, the destination OC-N port in the destination node. First, create a bidirectional circuit that starts on the node source OC-N port and loops back on the node destination OC-N port. Then proceed with the terminal loopback test. Completing a successful terminal loopback to a node destination OC-N port verifies that the circuit is good up to the destination OC-N. [Figure 1-20](#) shows an example of a terminal loopback on an intermediate node destination OC-N port.

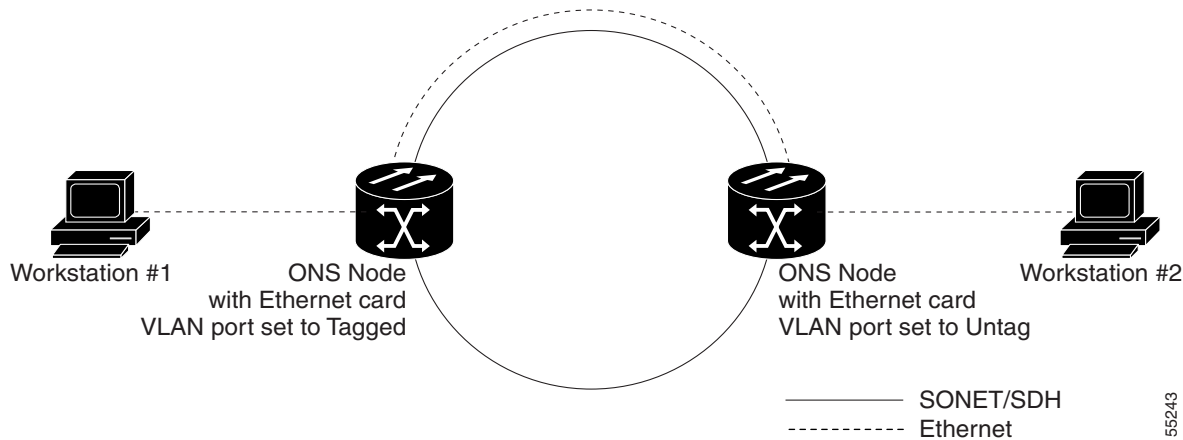
Figure 1-26 A VLAN with Ethernet ports at Tagged and Untag

Symptom Networks that have a VLAN with one ONS 15454 Ethernet card port set to Tagged and one ONS 15454 Ethernet card set to Untag might have difficulty implementing Address Resolution Protocol (ARP) for a network device attached to the Untag port (Figure 1-26). They might also see a higher than normal runt packets count at the network device attached to the Untag port. This symptom/limitation also exists when ports within the same card or ports within the same chassis are put on the same VLAN, with a mix of tagged and untagged.

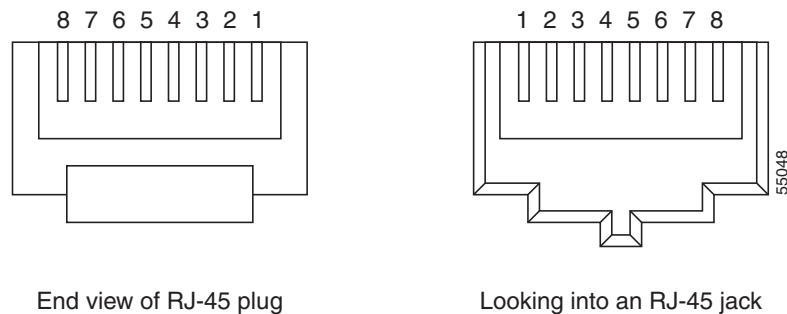
Figure 1-28 RJ-45 Pin Numbers

You can crimp your own LAN cables for use with the ONS 15454. Use a cross-over cable when connecting an ONS 15454 to a hub, LAN modem, or switch, and use a LAN cable when connecting an ONS 15454 to a router or workstation. Use CAT-5 cable RJ-45 T-568B, Color Code (100 Mbps), and a crimping tool. [Figure 1-28](#) shows the layout of an RJ-45 connector. [Figure 1-29](#) and [Table 1-39](#) shows a LAN cable layout and pinouts.

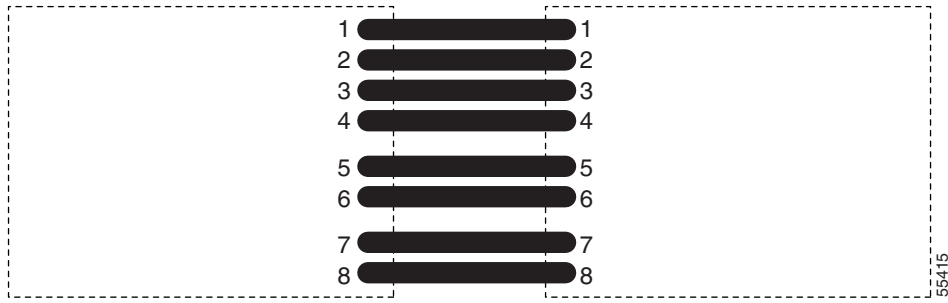
Figure 1-29 LAN Cable Layout

Pin	Color	Pair	Name	Pin
1	white/orange	2	Transmit Data +	1
2	orange	2	Transmit Data -	2
3	white/green	3	Receive Data +	3
4	blue	1		4
5	white/blue	1		5
6	green	3	Receive Data -	6
7	white/brown	4		7
8	brown	4		8

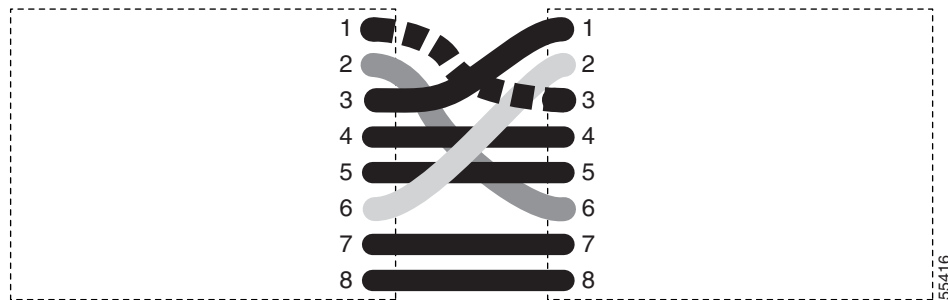
Figure 1-30 Cross-over Cable Layout

Figure 1-30 and Table 1-40 shows a cross-over cable layout and pinouts.

Pin	Color	Pair	Name	Pin
1	white/orange	2	Transmit Data +	3
2	orange	2	Transmit Data -	6
3	white/green	3	Receive Data +	1
4	blue	1		4
5	white/blue	1		5

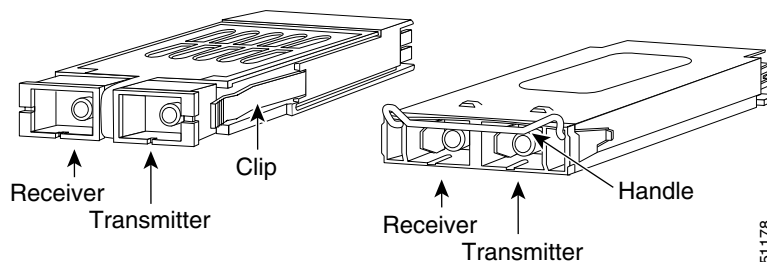
Figure 1-31 Gigabit Interface Converters

GBICs are available in two different models. One GBIC model has two clips (one on each side of the GBIC) that secure the GBIC in the slot on the E1000-2-G, G1000-4, or G1K-4 card. The other model has a locking handle. Both models are shown in [Figure 1-31](#).

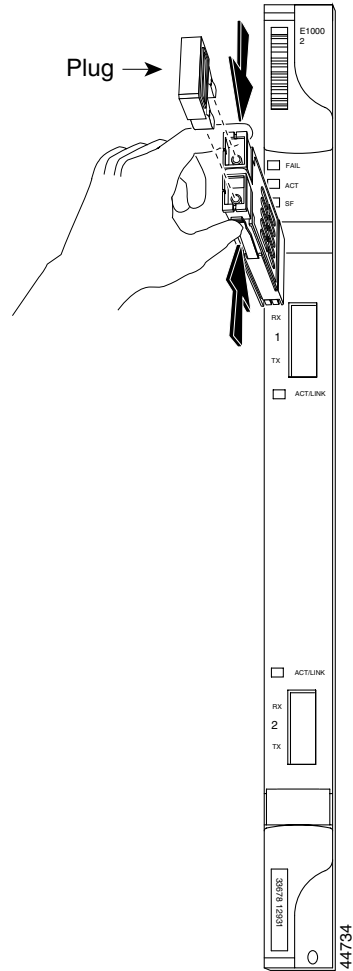
Figure 1-32 GBIC Installation (with Clips)

- Step 1** Remove the GBIC from its protective packaging.
- Step 2** Check the label to verify that the GBIC is the correct type (SX, LX, or ZX) for your network.
- Step 3** Verify that you are installing compatible GBICs; for example, SX to SX, LX to LX, or ZX to ZX.
- Step 4** Grip the sides of the GBIC with your thumb and forefinger and insert the GBIC into the slot on the E1000-2, E1000-2-G, or G1000-4 card (shown in [Figure 1-32](#)).

Note GBICs are keyed to prevent incorrect installation.

- Step 5** Slide the GBIC through the flap that covers the opening until you hear a click. The click indicates the GBIC is locked into the slot.
- Step 6** When you are ready to attach the network fiber-optic cable, remove the protective plug from the GBIC and save the plug for future use.
- Step 7** Return to your originating procedure (NTP).

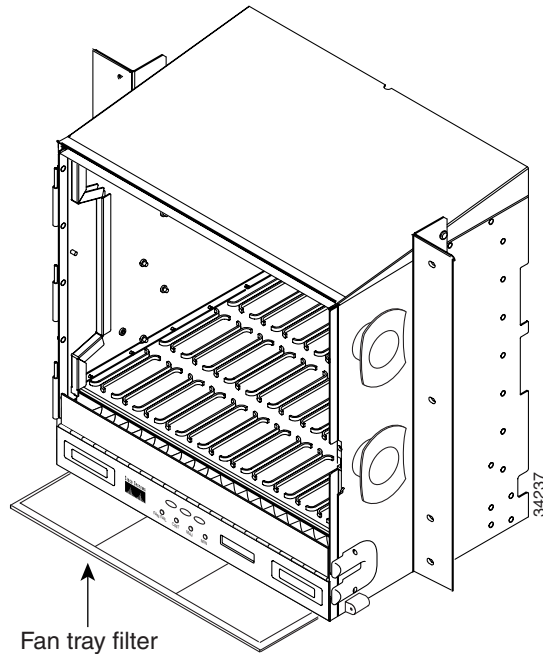
Figure 3-1 A Reusable Fan-Tray Air Filter in an External Filter Bracket (Front Door Removed)

- Step 1** Verify that you are replacing a reusable air filter. The reusable filter is made of a gray, open-cell, polyurethane foam that is specially coated to provide fire and fungi resistance. NEBS 3E and later versions of the ONS 15454 use a reusable air filter.
- Step 2** If the air filter is installed in the external filter brackets, slide the filter out of the brackets while being careful not to dislodge any dust that may have collected on the filter and proceed to [Step 3](#). [Figure 3-1](#) illustrates a reusable fan-tray air filter in an external filter bracket. If the filter is installed beneath the fan tray and not in the external filter brackets:
- a. Open the front door of the shelf assembly. If it is already open or the shelf assembly does not have a front door, continue with [Step 3](#).
 - Open the front door lock.

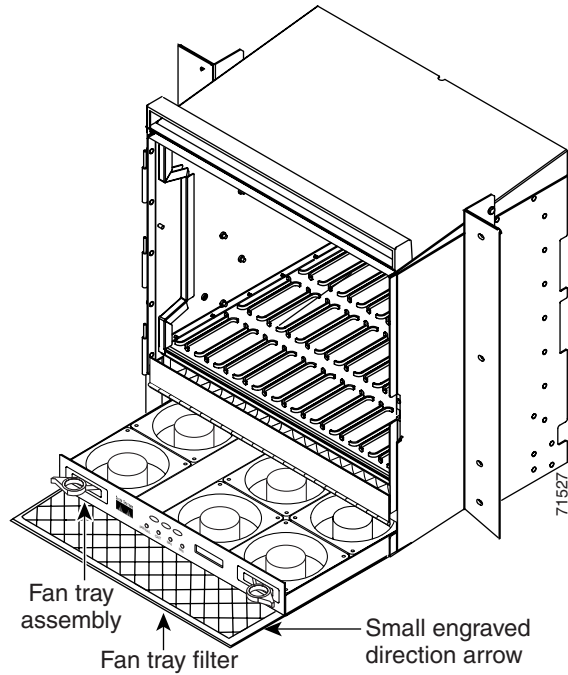
Figure 3-2 Inserting or Removing the Fan-Tray Assembly (Front Door Removed)

- Step 5** Pull the handles and slide the fan-tray assembly one inch out of the shelf assembly and wait until the fans stop.
- Step 6** When the fans have stopped, pull the fan-tray assembly completely out of the shelf assembly ([Figure 3-2](#)).

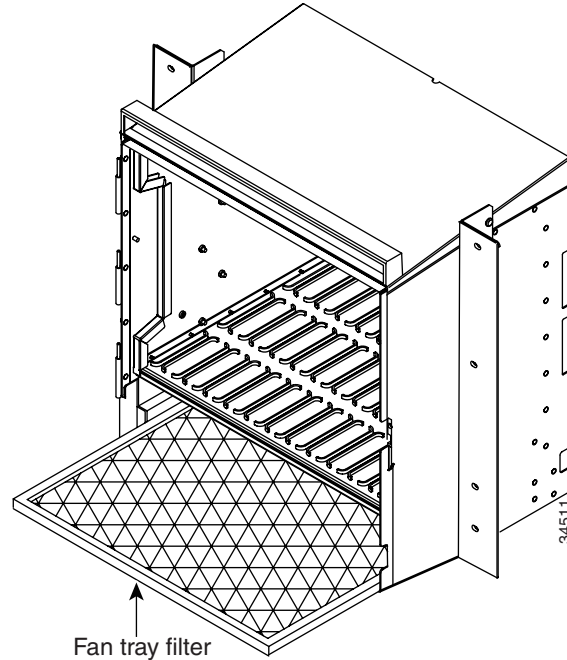
Figure 3-3 Inserting or Removing a Disposable Fan-Tray Air Filter (Front Door Removed)

- Step 7** Gently remove the air filter from the shelf assembly (Figure 3-3). Be careful not to dislodge any dust that may have collected on the filter.
- Step 8** Visually inspect the white filter material for dirt and dust.
- Step 9** If the air filter shows a heavy concentration of dirt and dust, replace it with a new filter by sliding the filter into the bottom of the shelf assembly. Make sure that the front of the filter is flush with the front of the shelf assembly and that the air flow indicators on the filter point upwards.

- Step 10** Slide the fan-tray assembly into the shelf assembly until the electrical plug at the rear of the tray plugs into the corresponding receptacle on the backplane.
- Step 11** To verify that the tray is plugged into the backplane, ensure that the LCD on the front of the fan-tray assembly is activated and displays node information.
- Step 12** Rotate the retractable handles back into their compartments.
- Step 13** If you replace the door, also reattach the group strap.

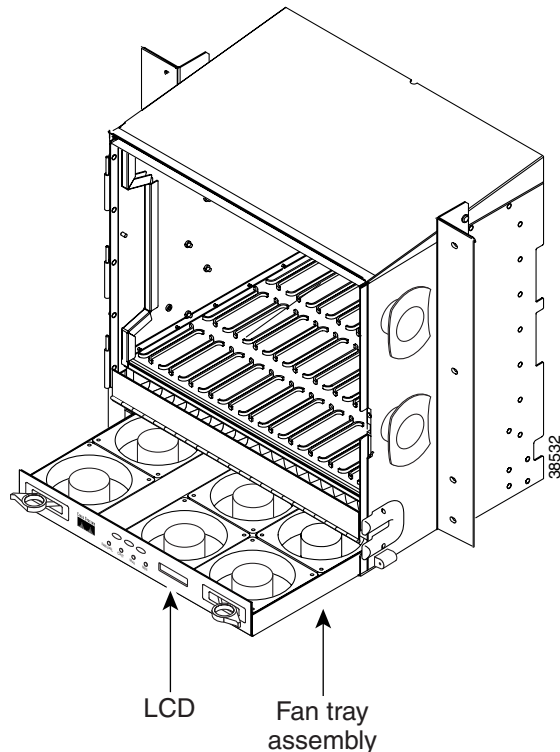
Figure 3-4 Removing or Replacing the Fan-Tray Assembly (Front Door Removed)

- Step 6** When the fans have stopped, pull the fan-tray assembly completely out of the shelf assembly. [Figure 3-4](#) shows the location of the fan tray.

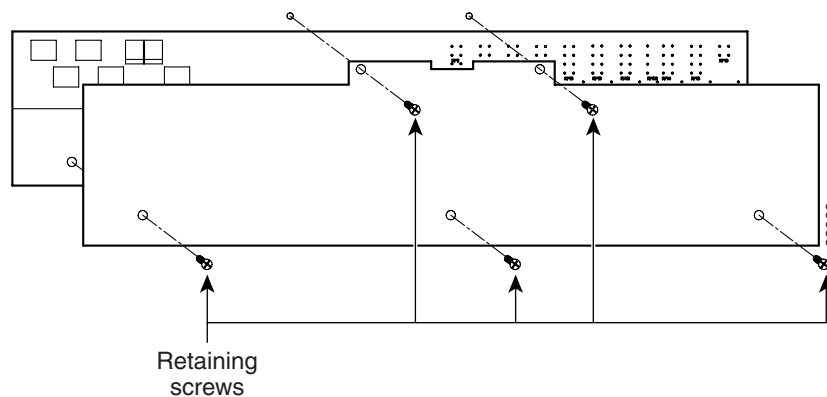
Figure 3-6 Lower Backplane Cover

- Step 3** Call Cisco TAC at 800-553-3227 for assistance in replacing the AIP and maintaining the original MAC address.
- Step 4** Unscrew the five screws that hold the lower backplane cover in place (Figure 3-6).
- Step 5** Grip the lower backplane cover and gently pull it away from the backplane.

Step 1 To remove the lower backplane cover, loosen the five screws that secure it to the ONS 15454 and pull it away from the shelf assembly (Figure 3-6).
