Cisco ONS 15454 Troubleshooting Guide

Product and Documentation Release 4.1.x and Release 4.5
Last Updated: October 22, 2007

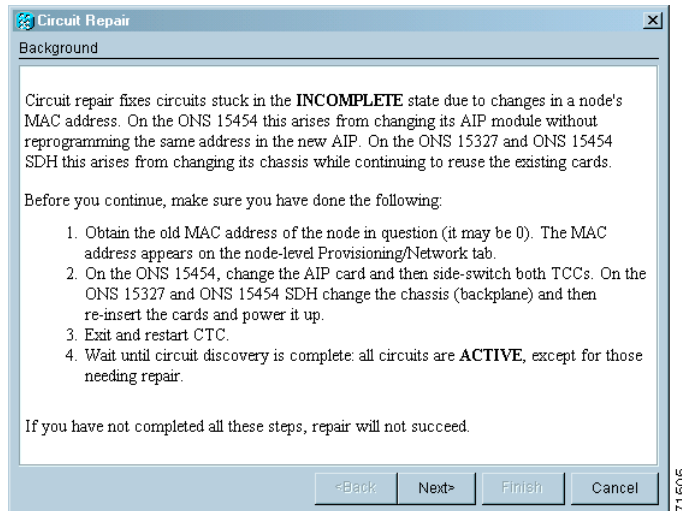
Figure 3-7 Repairing Circuits

- b. Record the MAC address shown in the General tab.
- Step 21** In node view, click the **Circuits** tab. Note that all circuits listed are in an **INCOMPLETE** state.
- Step 22** In node view, choose **Repair Circuits** from the **Tools** pull-down menu. The Circuit Repair dialog box is displayed.
- Step 23** Read the instructions in the Circuit Repair dialog box (Figure 3-7). If all the steps in the dialog box have been completed, click **Next>**. Ensure you have the old and new MAC addresses.
