Cisco ONS 15454 DWDM Troubleshooting Guide

Product and Software Release 9.0
June 2012

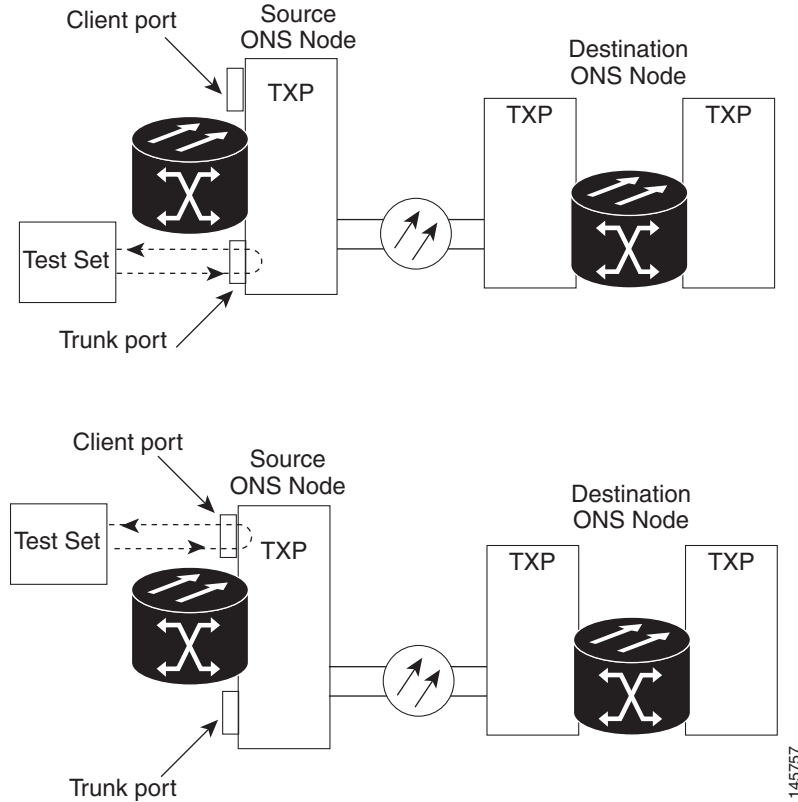
Figure 1-3 Facility Loopback on a Circuit Source MXP or TXP Port

This facility loopback test is performed on the node source port in the network circuit. In the testing situation used in this example, the source muxponder, transponder, xponder, or ADM-10G port under test is located in the source node. Facility loopback can be performed at the trunk port or at a client port. Completing a successful facility loopback on this port isolates the source MXP, TXP, XP, or ADM-10G port as a possible failure point. [Figure 1-3](#) shows the facility loopback examples on source ONS node TXP ports (client and trunk).

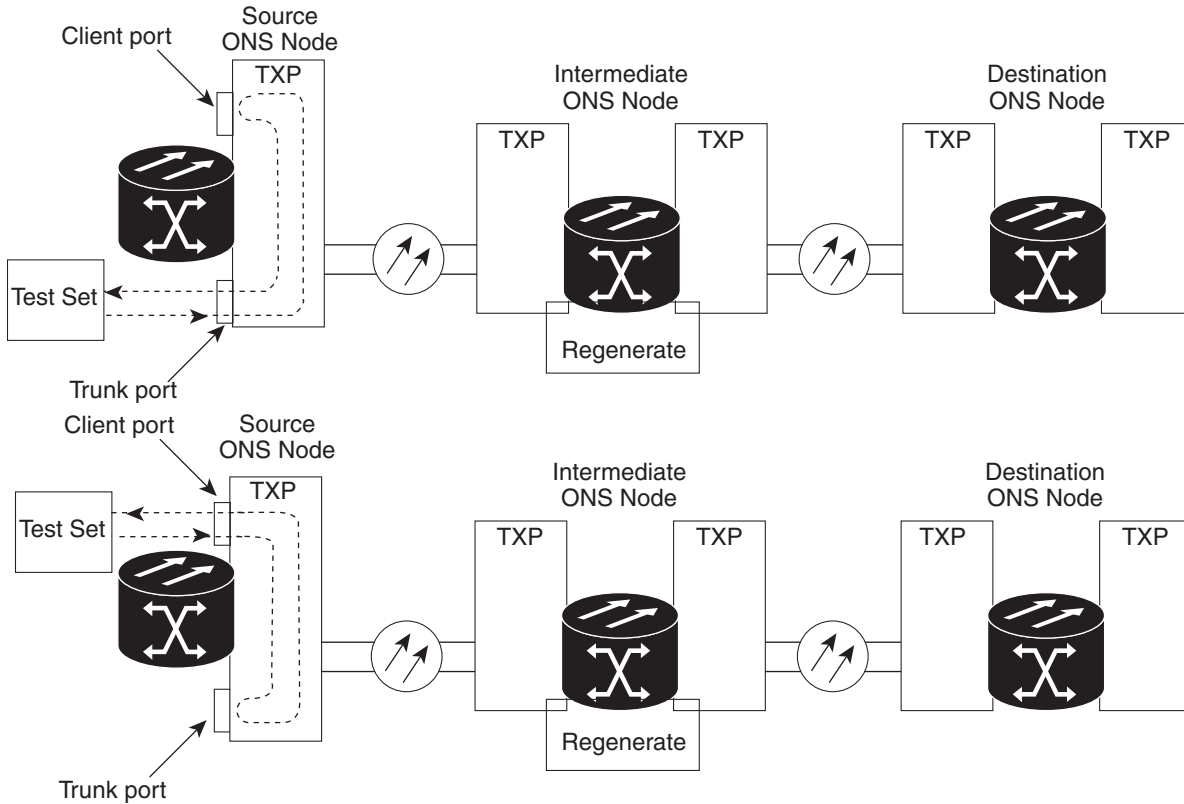
Figure 1-4 Terminal Loopback on a Source-Node MXP or TXP Port

The terminal loopback test is performed on the node source MXP, TXP, XP, or ADM-10G port. For the circuit in this example, it is the source TXP trunk port or a client port in the source node. Completing a successful terminal loopback to a node source port verifies that the circuit is through the source port. [Figure 1-4](#) shows an example of a terminal loopback on a source TXP port and a client TXP port.

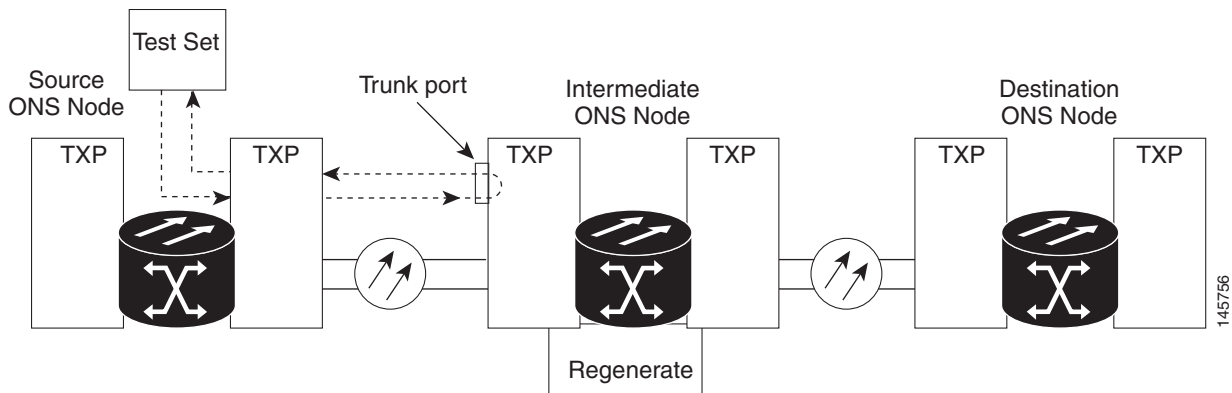
Figure 1-5 Facility Loopback on an Intermediate-Node MXP or TXP Port

Performing the facility loopback test on an intermediate port isolates whether this node is causing circuit failure. In the situation shown in [Figure 1-5](#), the test is being performed on an intermediate MXP or TXP port.

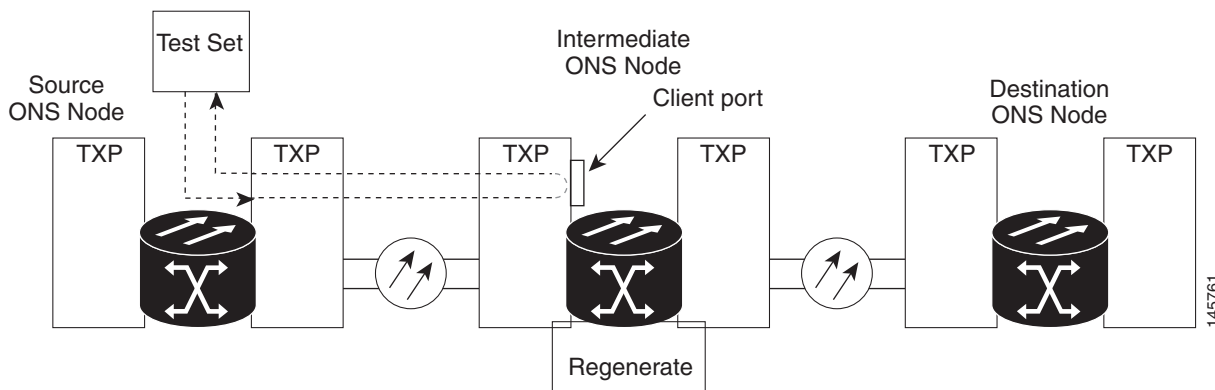
Figure 1-6 Terminal Loopback on an Intermediate-Node MXP or TXP Port

In the next troubleshooting test, you perform a terminal loopback on the intermediate-node port to isolate whether the intermediate client or trunk port is causing circuit trouble. In the example situation in [Figure 1-6](#), the terminal loopback is performed on an intermediate MXP or TXP port in the circuit. If you successfully complete a terminal loopback on the node, this node is excluded from possible sources of circuit trouble.

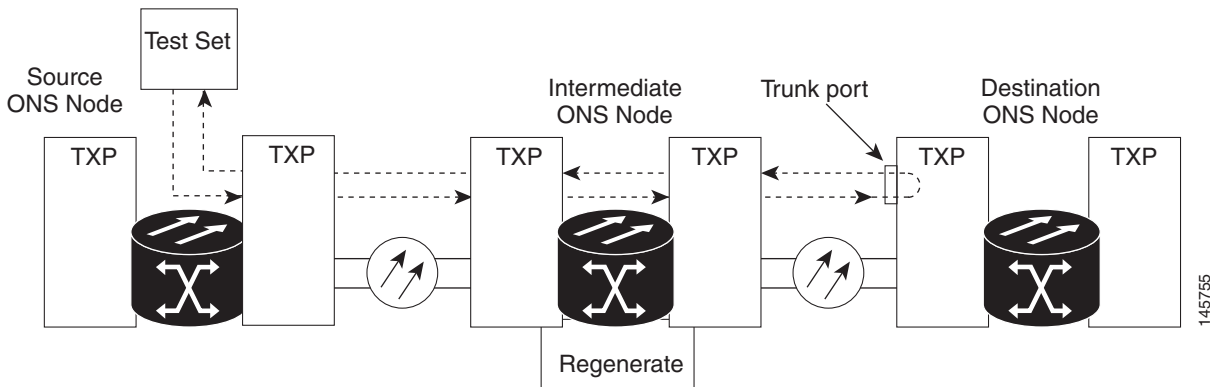
Figure 1-7 Facility Loopback on a Destination-Node MXP or TXP Port

You perform a facility loopback test at the destination port to determine whether this local port is the source of circuit trouble. The example in [Figure 1-7](#) shows a facility loopback being performed on a TXP client or trunk port at a destination node.

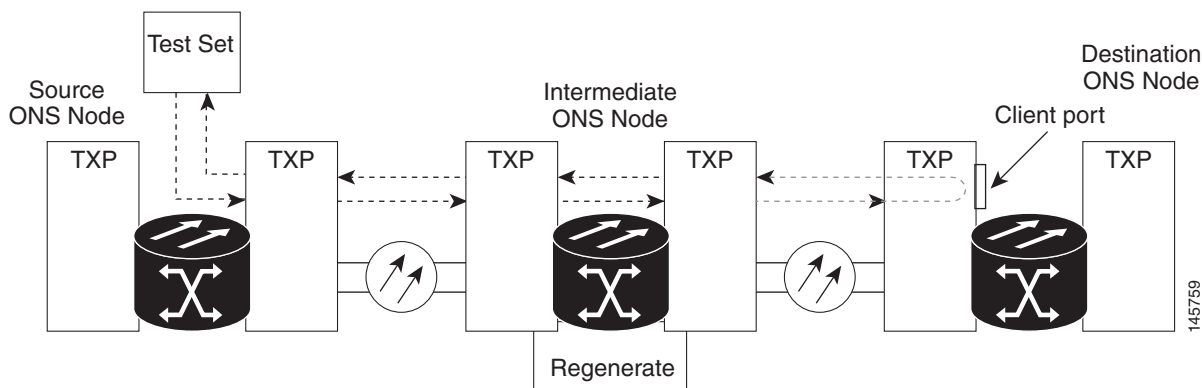
Figure 1-8 Terminal Loopback on a Destination-Node MXP or TXP Port

The terminal loopback at the destination-node port is the final local hardware error elimination in the circuit troubleshooting process. If this test is completed successfully, you have verified that the circuit is good up to the destination port. The example in [Figure 1-8](#) shows a terminal loopback on an destination node TXP port.

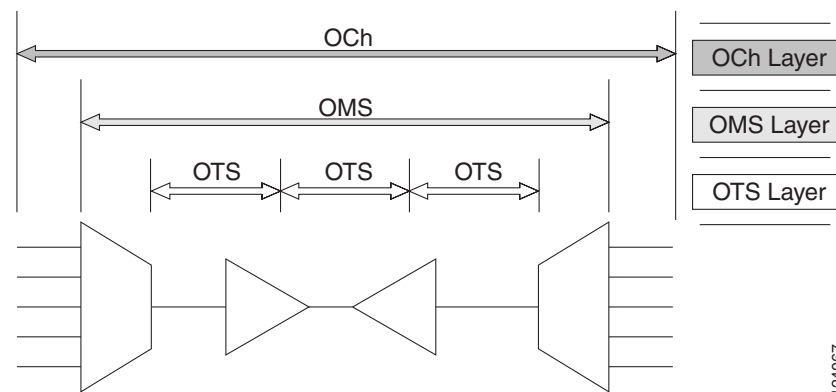
Figure 1-9 Optical Transport Network Layers

Like traditional SONET networks, ITU-T G.709 optical networks have a layered design (Figure 1-9). This structure enables localized monitoring that helps you isolate and troubleshoot network problems.

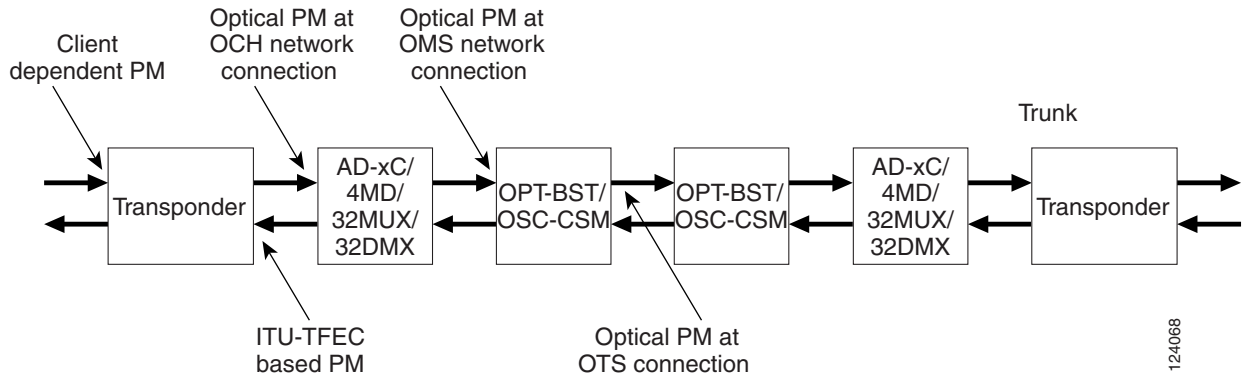
Figure 1-10 Performance Monitoring Points on ONS DWDM

Different PM count parameters are associated with different read points in a network. [Figure 1-10](#) illustrates the PM read points that are useful in identifying DWDM circuit points of failure. The “Performance Monitoring” chapter in the *Cisco ONS 15454 DWDM Reference Manual* lists all PM parameters and provides block diagrams of signal entry points, exit points, and interconnections between the individual circuit cards. Consult these specifications to determine which PM parameters are associated with the system points you want to monitor or provision with CTC or TL1. The monitoring points might vary according to your configuration.

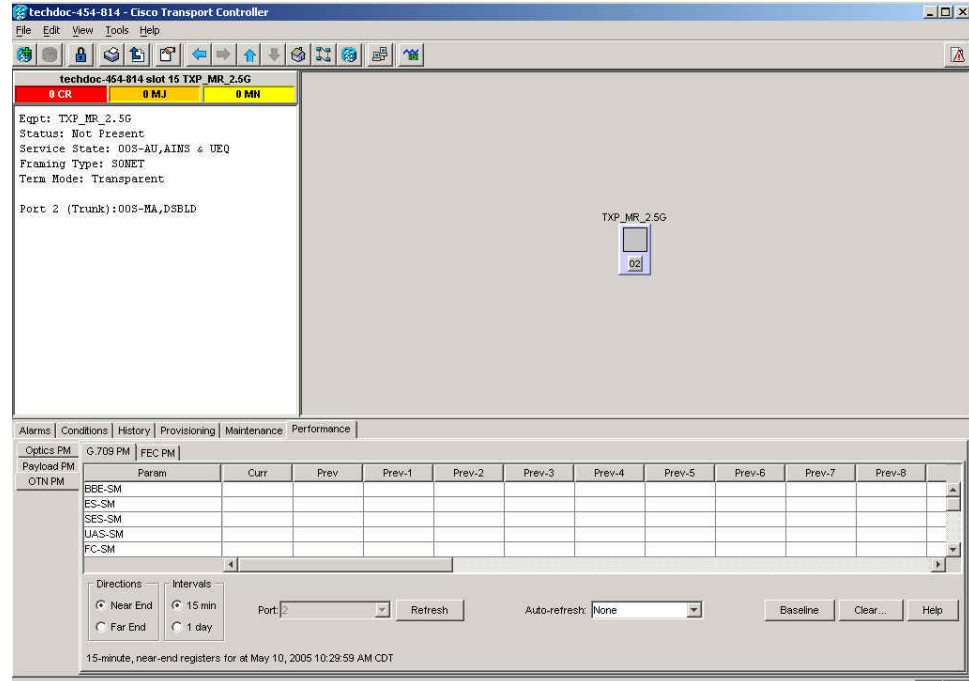
Figure 1-12 Provision Card BBE/SES Thresholds

- Step 1** In node view (single-shelf mode) or shelf view (multishelf mode), double-click the applicable card (TXP, MXP, or XP.)
- Step 2** Click the **Provisioning > OTN > G.709 Thresholds** tabs (Figure 1-12).

- Step 3** In the Directions area, click the **Near End** radio button.
- Step 4** In the Intervals area, click the **15 Min** radio button.
- Step 5** In the Types area, click the **PM (ODUk)** radio button.
- Step 6** In the SES and BBE fields, enter threshold numbers, for example 500 and 10000.

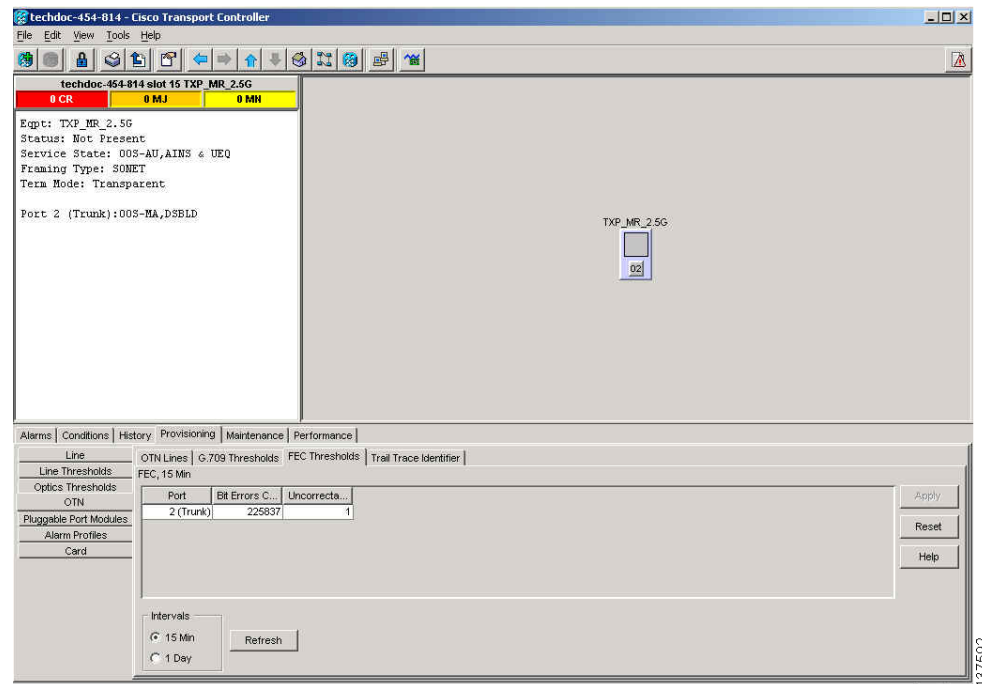
Figure 1-14 Provision Card FEC Thresholds

- Step 1** In node view (single-shelf mode) or shelf view (multishelf mode), double-click a transponder, muxponder, or xponder card to open the card view.
- Step 2** Click the **Provisioning > OTN > FEC Thresholds** tabs (Figure 1-14).

- Step 3** In the Bit Errors Corrected field, enter a threshold number, for example 225837.
- Step 4** In the Uncorrectable Words field, enter a threshold number, for example, 2.
- Step 5** In the Intervals area, click **15 Min**.

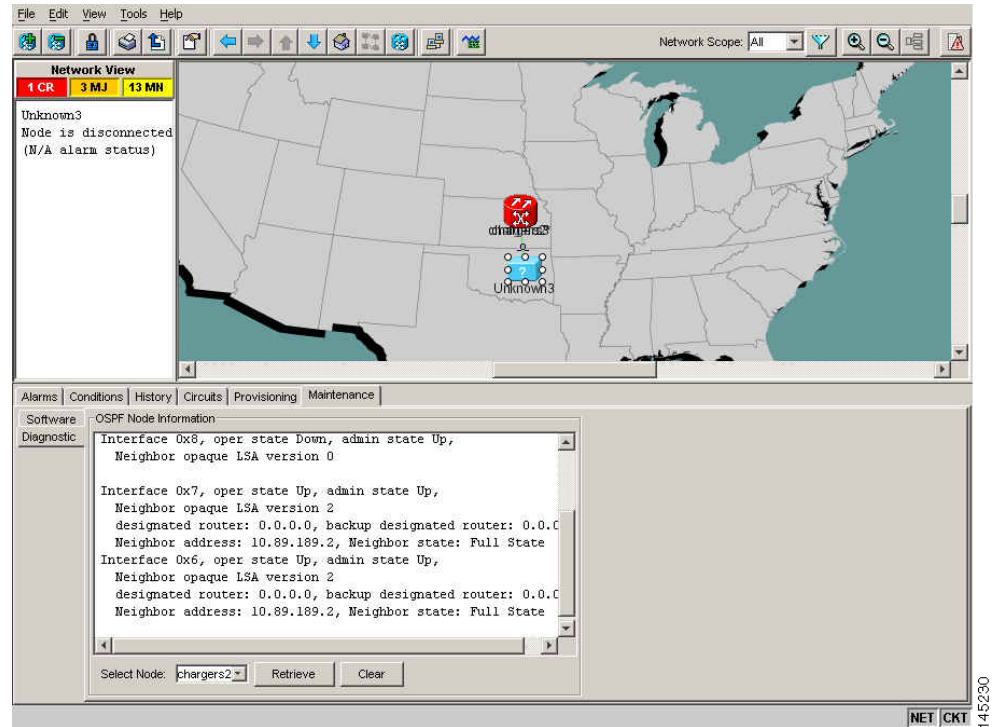
Figure 1-16 DCN Tools OSPF Dump

CTC contains a data communications network (DCN) tool that assists with network troubleshooting for Open Shortest Path First (OSPF) networks. This tool, located in network view, is shown in Figure 1-16. It executes an internal dump command to retrieve information about all nodes accessible from the entry point.

The dump, which provides the same information as a dump executed by special networking commands, is available at the network view in the Maintenance > Diagnostic tab. You can select the access point node in the Select Node drop-down list. To create the dump, click Retrieve. (To clear the dump, click Clear.)

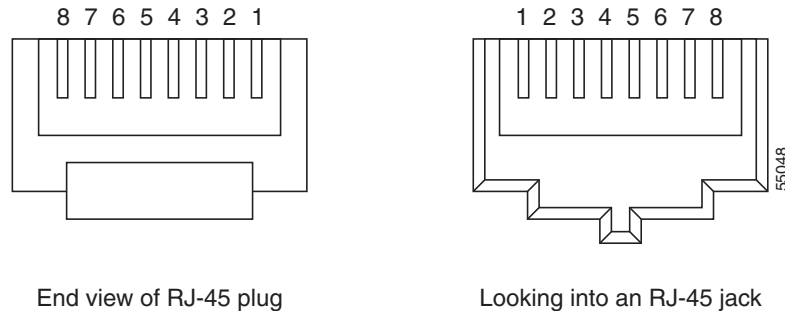
Figure 1-18 RJ-45 Pin Numbers

You can crimp your own LAN cables for use with the ONS 15454. Use a cross-over cable when connecting an ONS 15454 to a hub, LAN modem, or switch, and use a LAN cable when connecting an ONS 15454 to a router or workstation. Use CAT-5 cable RJ-45 T-568B, Color Code (100 Mbps), and a crimping tool. Figure 1-18 shows the wiring of an RJ-45 connector. Figure 1-19 shows a LAN cable layout, and Table 1-7 shows the cable pinouts. Figure 1-20 shows a cross-over cable layout, and Table 1-8 shows the cross-over pinouts.

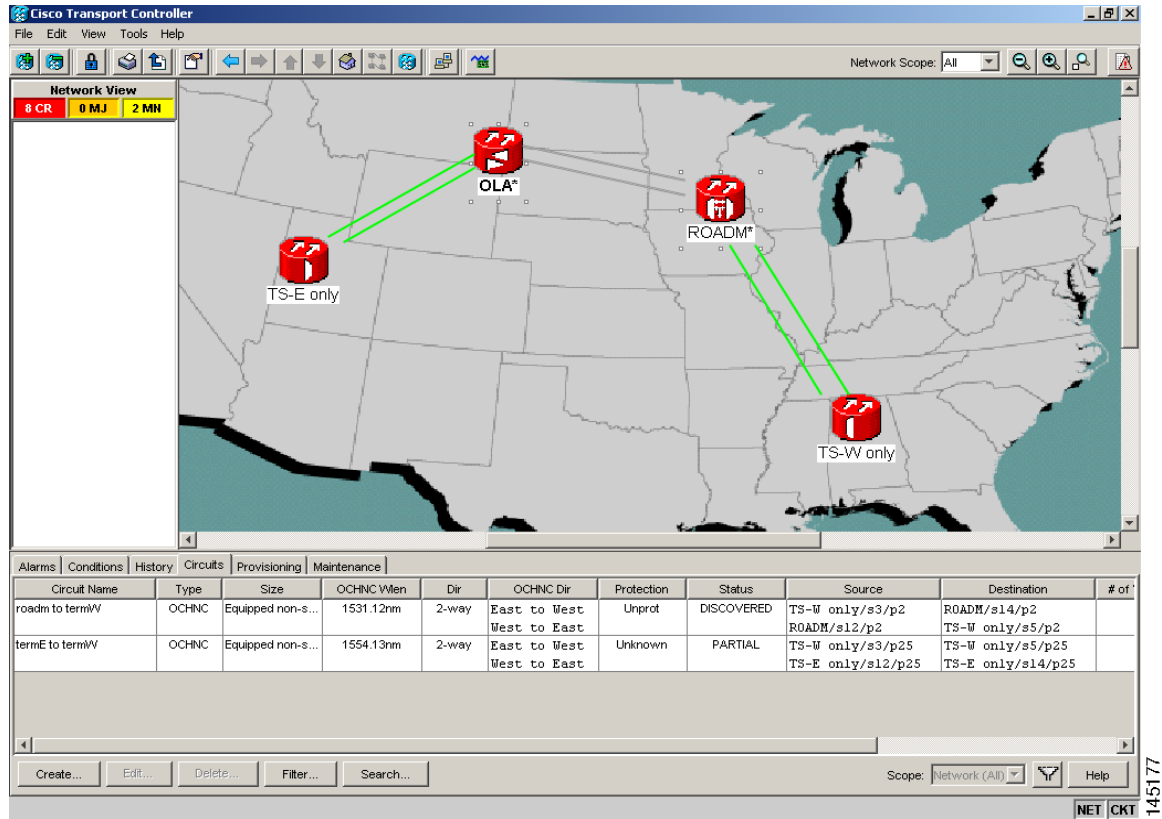
Figure 1-22 Fiber Cut with ALS MODE = Auto Restart

The final fault condition of the network is shown in [Figure 1-22](#).

In network view, both of the lines representing the span were formerly green and have now changed to gray. Notice also that the status of all the OCHNC circuits on the broken span have changed from Discovered to Partial.

The basic assumption is that the network ALS feature (for feature details, refer to the “Network Optical Safety—Automatic Laser Shutdown” section in the *Cisco ONS 15454 DWDM Reference Manual*) is active (ALS Mode = Auto Restart on the OPT-BST, OPT-AMP-x-C, [+ OSCM] and OSC-CSM). Given this assumption, the starting condition is as shown in [Figure 1-22 on page 1-63](#).

An EOC condition is always present on both nodes because the OSC optical link is down due to an incoming power level lower than the optical sensitivity limit (−42 dBm). The system condition remains unchanged as illustrated in [Figure 1-22](#).

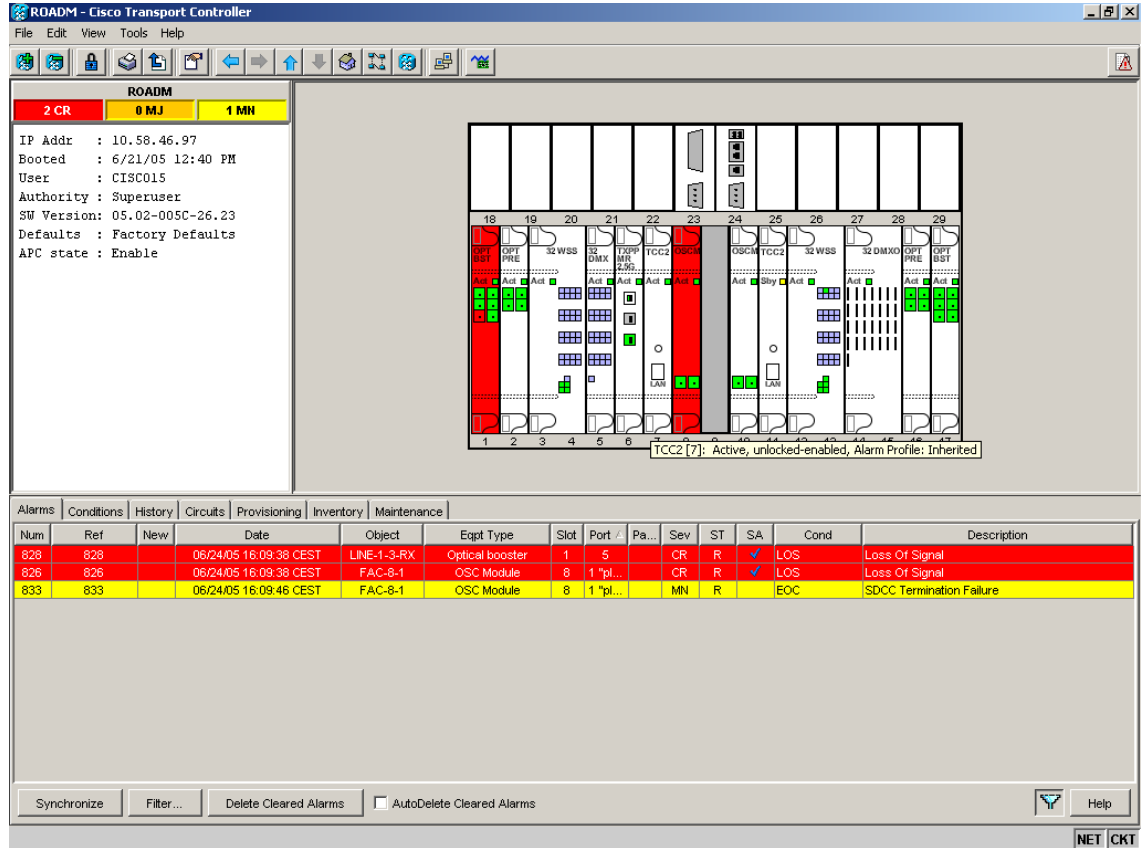
Figure 1-24 LOS Indication on the OLA Node OPT-BST

In node view (single-shelf mode) or shelf view (multishelf mode), the alarm panel of the two nodes (reconfigurable optical add/drop multiplexing [ROADM] and optical line amplification [OLA] in the example) show the LOS (AOTS) alarm on Port 4 of the OSC-CSM (see Figure 1-23) and the LOS (OTS) on Port 5 of the OPT-BST (see Figure 1-24).

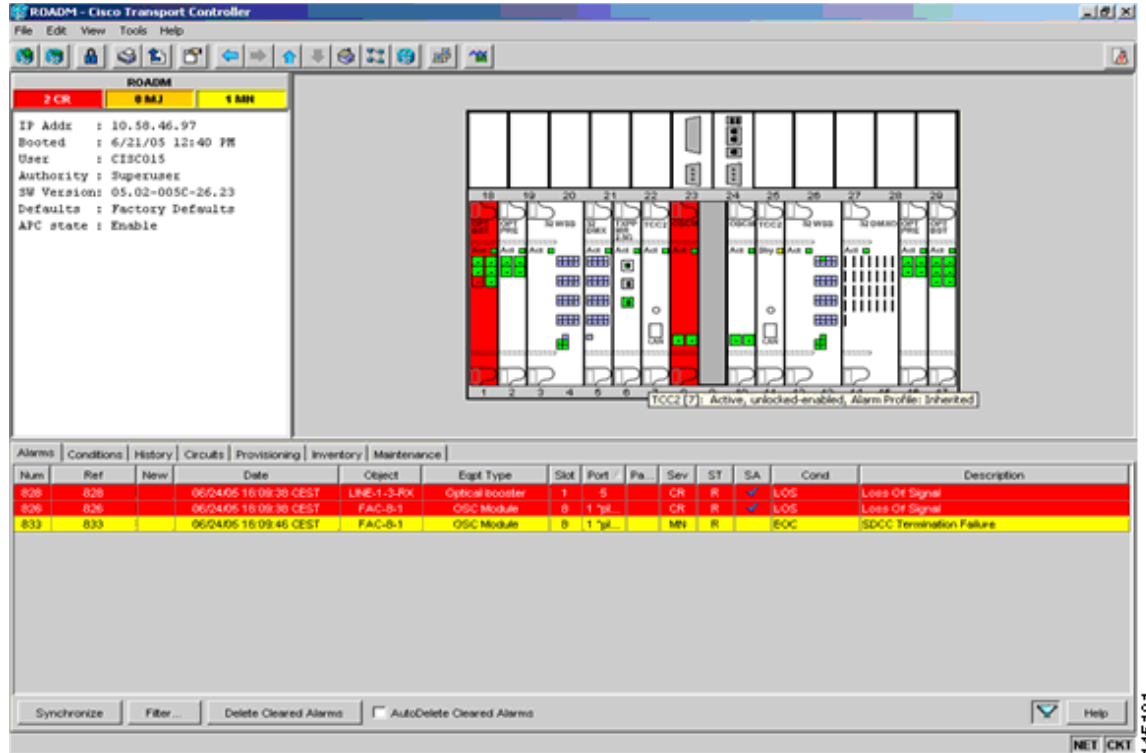
Figure 1-26 ONS 15454 SDH ROADM Node View with Fault Condition for ALS MODE Disabled

In node view (single-shelf mode) or shelf view (multishelf mode) (Figure 1-26 and Figure 1-27), the alarm panel of the receiving node (ROADM in this example) reports the LOS (OTS), while the transmitting node (OLA) reports only an EOC alarm.

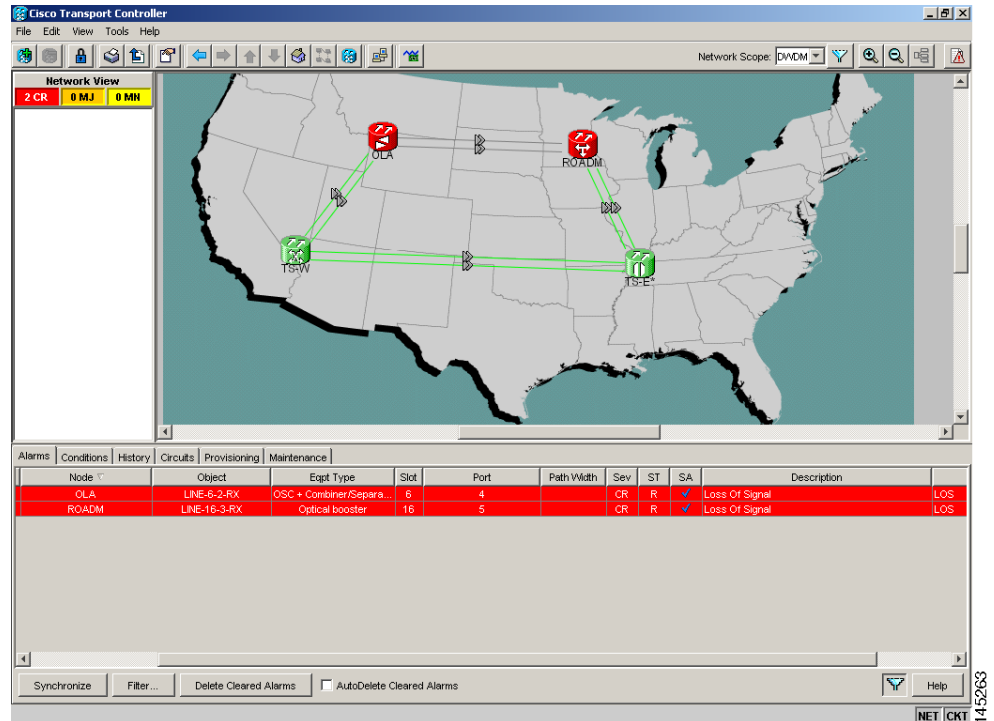
Figure 1-28 Network View for Span Loss Change > 5 dBm and OSC Power Value at Receiver > -42 dBm

This change is due to the fact the physical optical power value received by the OSC transceiver is above the sensitivity limit (-42 dBm) and consequently, the OSC optical link can be rebuilt, allowing the restoration of the Section DCC (SDCC) or multiplex section DCC (MS-DCC). The network view for this condition is shown in [Figure 1-28](#).

In node view (single-shelf mode) or shelf view (multishelf mode), the EOC condition is cleared, but the alarm panels of the two nodes (ROADM and OLA in the example) continue to show LOS (OTS or AOTS) on the LINE-RX port of the OPT-BST, OPT-AMP-x-C, or OSC-CSM.

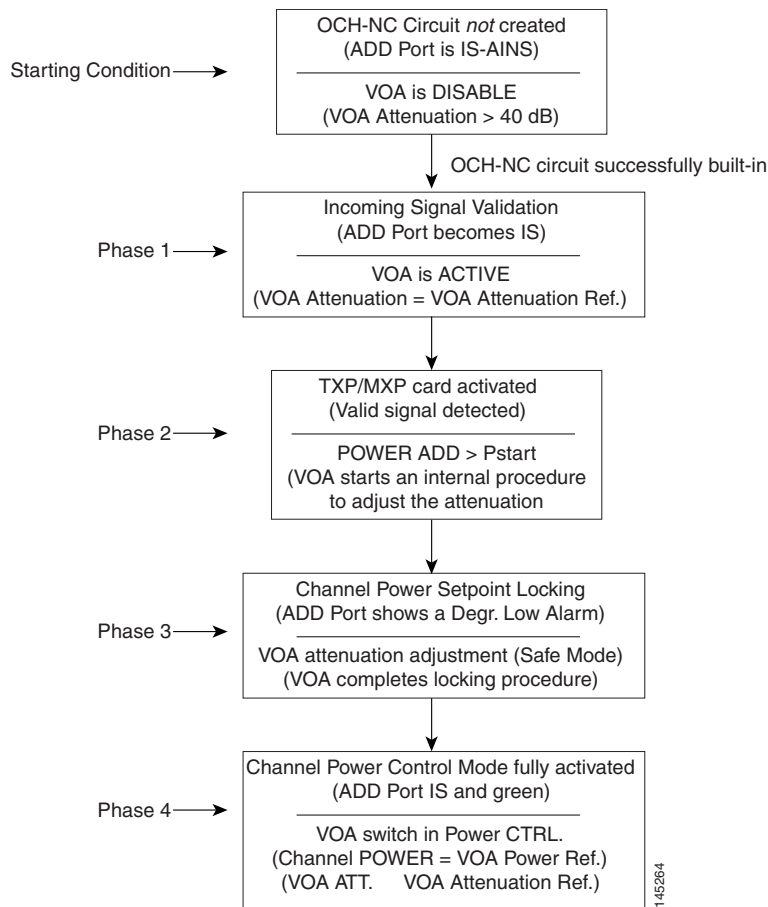
Figure 1-32 VOA Startup Procedure

The final VOA condition is achieved through a startup procedure divided into the four sequential phases shown in [Figure 1-32](#).

Until the VOA has completed all the phases shown in [Figure 1-32](#), the power control mode is not fully activated.

When the power is lower than expected, the start-up procedure can stop at Phase 1, Phase 2, or Phase 3 (see [Figure 1-32](#)). The point at which the start-up procedure stops depends on the amount of power missing.

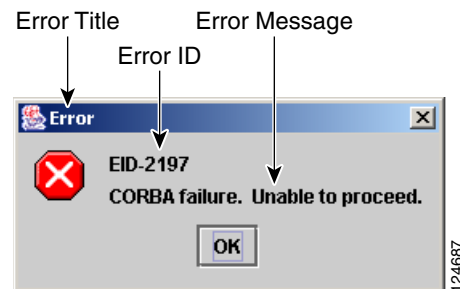
**Figure 4-1** Error Dialog Box

This chapter lists the error messages for the Cisco ONS 15454 Multi-Service Transport Platform (MSTP). The error dialog box in [Figure 4-1](#) consists of three parts: the error title, error ID, and error message.
