## General Troubleshooting

This chapter provides procedures for troubleshooting the most common problems encountered when operating a DWDM shelf in ANSI or ETSI platforms. To troubleshoot specific alarms, see [Alarm Troubleshooting](#). If you cannot find what you are looking for, contact Cisco Technical Support (1 800 553-2447).

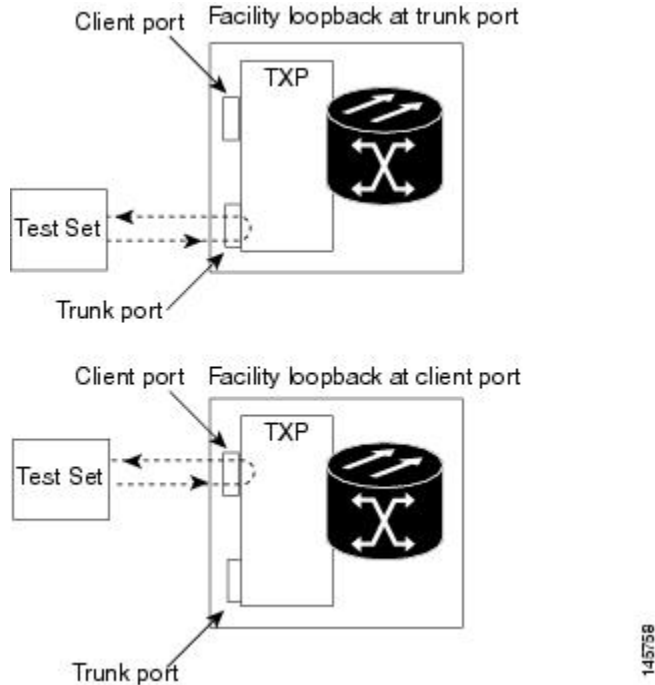
Figure 1: Facility Loopback Path on a Near-End Transponder Card

A facility loopback tests the line interface unit (LIU) of a card, the electrical interface assembly (EIA), and related cabling. After applying a facility loopback on a port, use a test set to run traffic over the loopback. A successful facility loopback isolates the LIU, the EIA, or the cabling plant as the potential cause of a network problem.

Figure 1: Facility Loopback Path on a Near-End Transponder Card, on page 3 shows a facility loopback at a trunk port and at a client port on a TXP card.

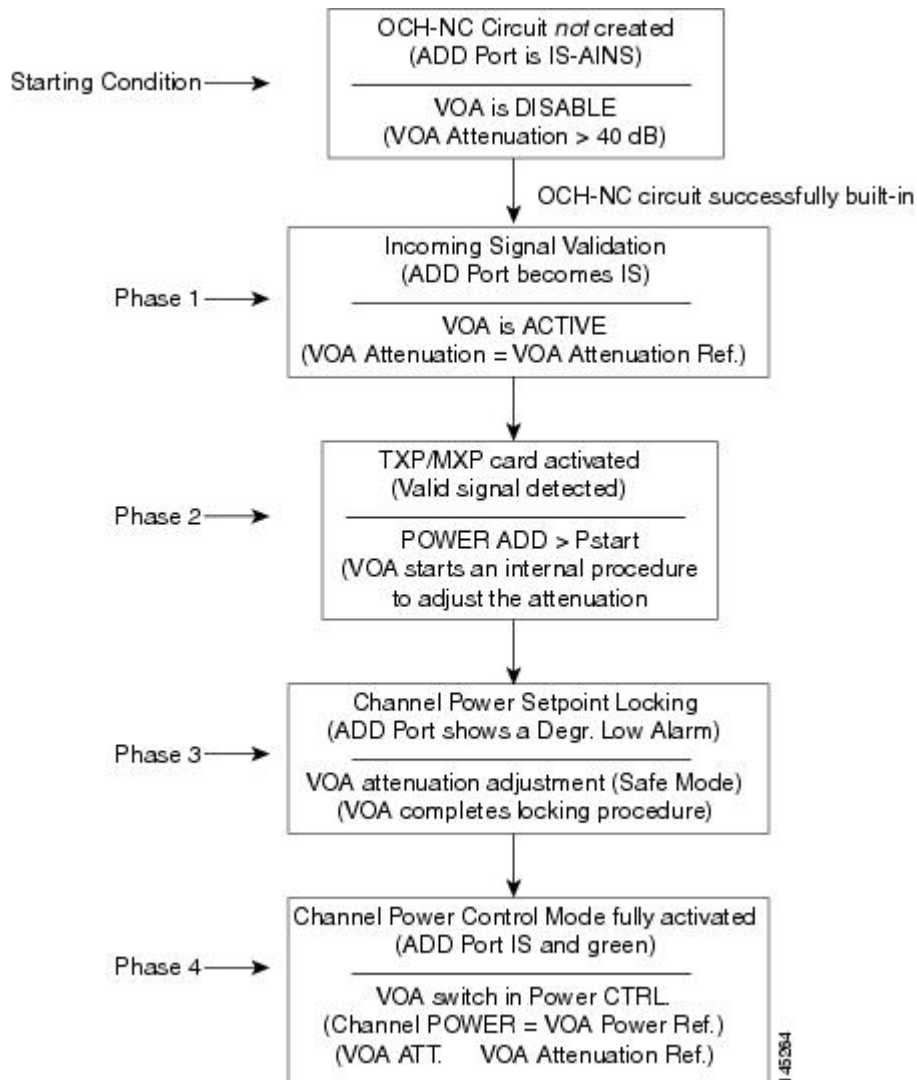
**Figure 18: VOA Startup Procedure**

The final VOA condition is achieved through a startup procedure divided into the four sequential phases shown in [Figure 18: VOA Startup Procedure, on page 76](#).

Until the VOA has completed all the phases shown in [Figure 18: VOA Startup Procedure, on page 76](#), the power control mode is not fully activated.

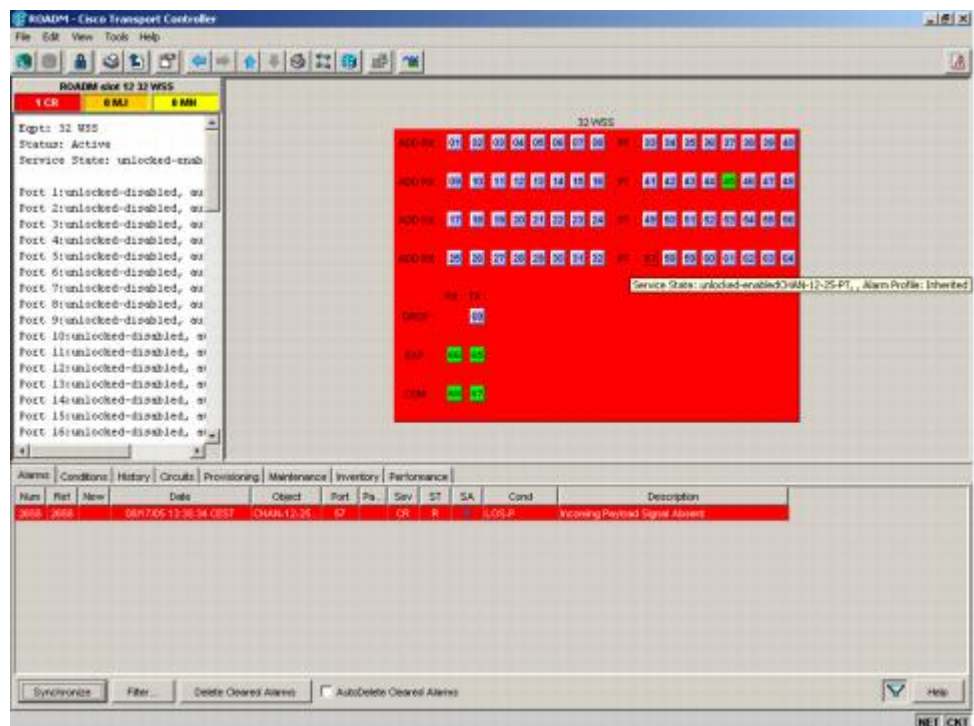
**Figure 19: LOS-P Indication on the VOA Port**

If the incoming power level is lower than the minimum allowed, the startup procedure always stops at Phase 1 (see [Figure 19: LOS-P Indication on the VOA Port, on page 78](#)). This is the case even if the final VOA Power Reference reported in CTC is reachable.

- A LOS-P (OCH layer) alarm on the port associated with the VOA (see [Figure 19: LOS-P Indication on the VOA Port, on page 78](#))
- A valid optical power value (different from the end of scale value of  $-50$  dBm) in the Power field, but the value for Power is less than  $-33$  dBm. (To view the Power field, in card view, click the **Provisioning** > **Parameters** tabs.)
