Recover a Catalyst 9800 Controller from ROMMON Mode

This document describes how to recover a Catalyst 9800 controller based on ROMMON mode and no image in the flash.

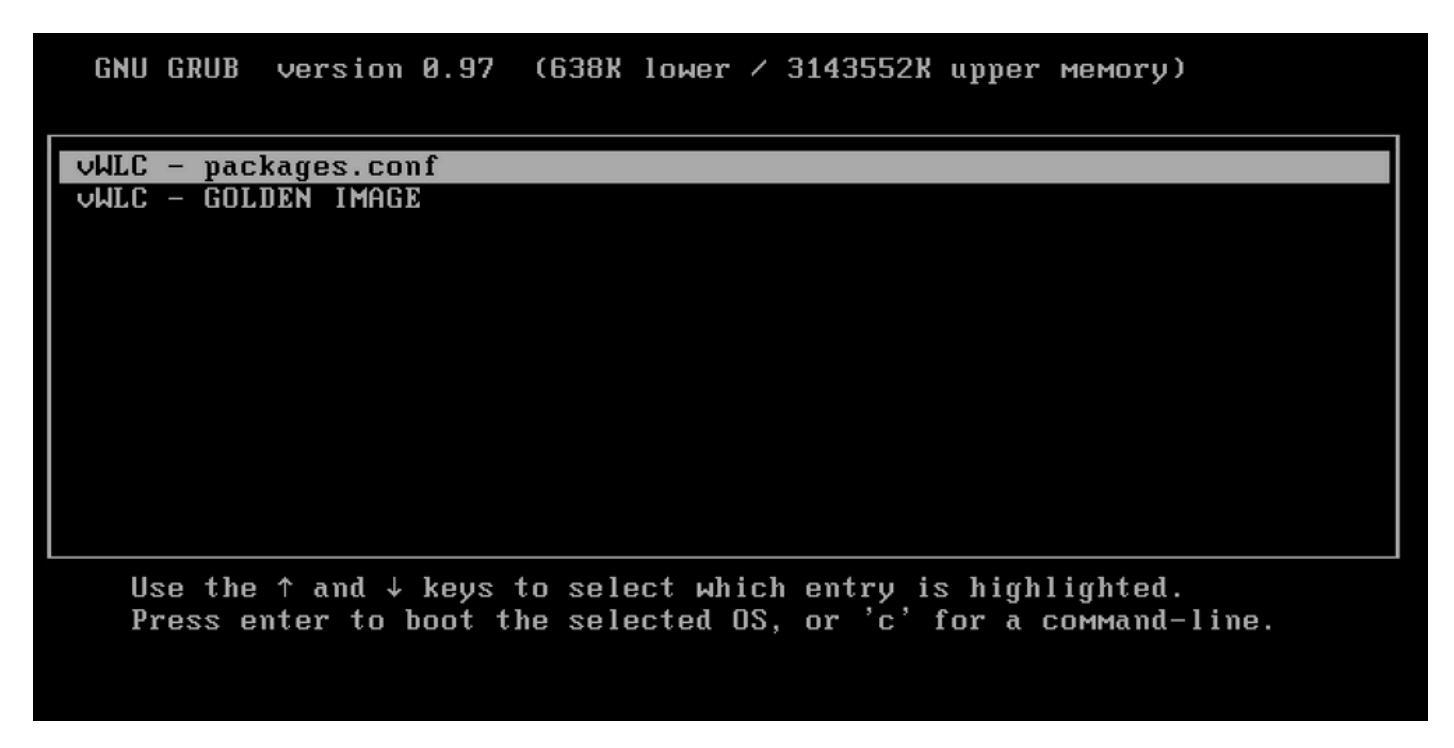
Step 1. Reboot the 9800-CL. You quickly see a boot selection screen:

Step 2. Press \mathbf{C} on this screen to get the grub prompt.

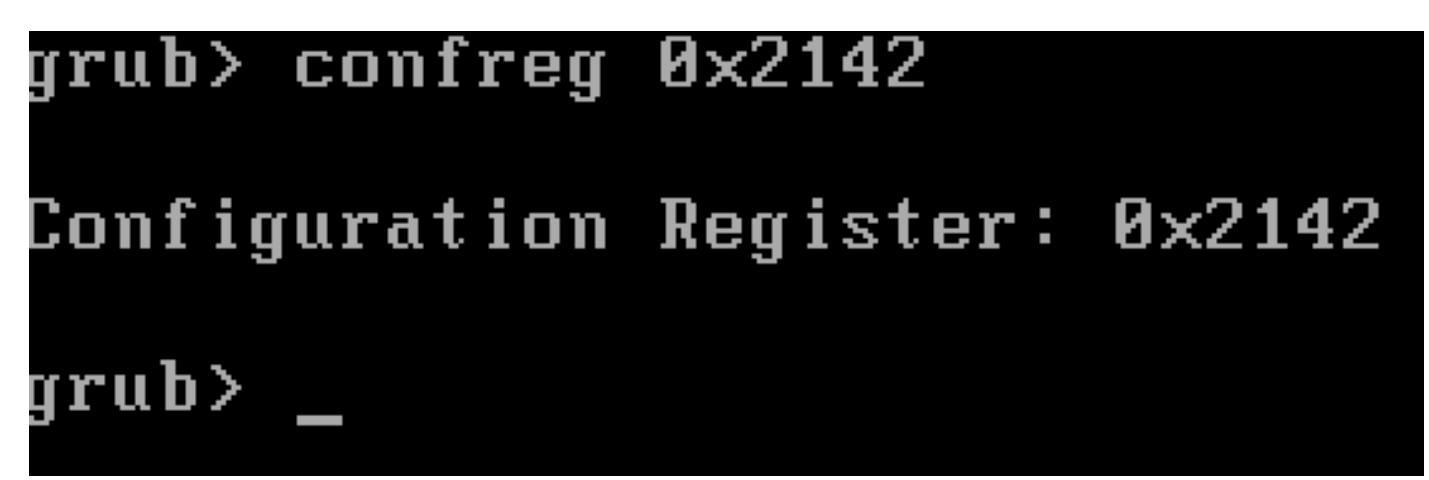
Step 3. You can change the config register in that prompt with the config 0x2142 command.

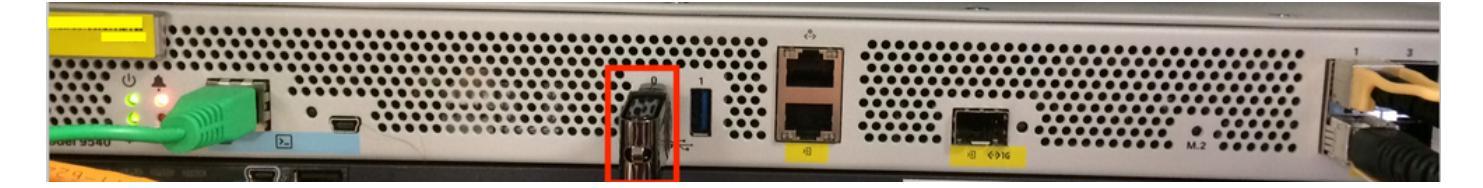
Front view:

Step 2. Connect the USB driver to the USB port 0 of the 9800.
