在Meraki解決方案中配置接入點配置檔案

本文檔介紹將站點A接入點(AP)1移至建議的配置檔案(AB和CD)並將AP2移至臨時配置檔案的過程。

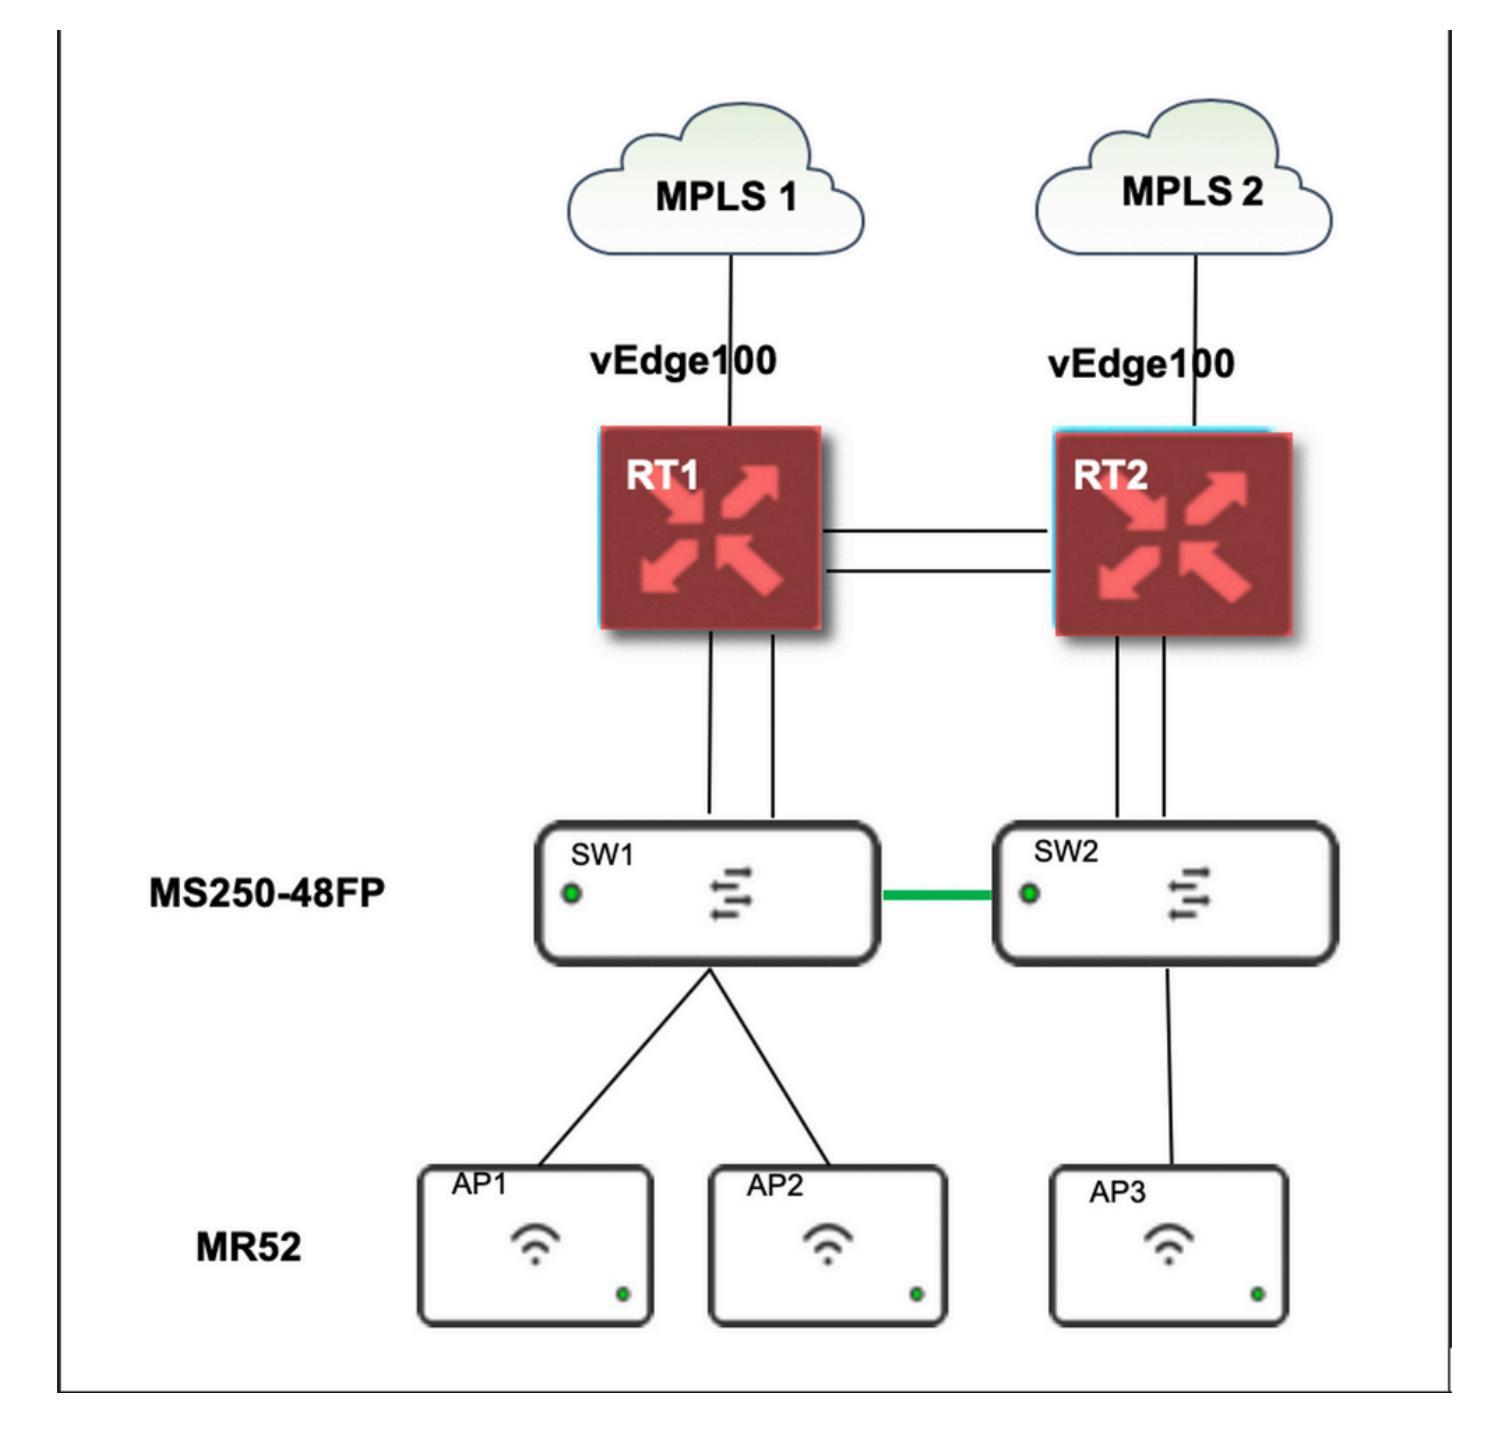
需要更改Meraki中的AP配置檔案。

- 1. 登入到Meraki GUI
- 2. 導覽至Network > Site ID > Wireless > Radio Settings
- 3. 選擇除AP2(x2)以外的所有AP,然後依次選擇Edit Settings > Assign profile
- 4. 選擇Profile_18Mbps_40MHz,按一下next並儲存
- 5. 導覽至Network > Site ID > Wireless > Radio Settings
- 6. 為AP2選擇兩個無線電,然後選擇編輯設定> 分配配置檔案
- 7. 選擇**Profile_18Mbps_40MHz_Exclude_161**,按一下**next**並**儲存** 如圖所示:
